# DURABILITY DESIGN OF CONCRETE STRUCTURES IN SEVERE ENVIRONMENTS

**ODD E. GJØRV**

Taylor & Francis

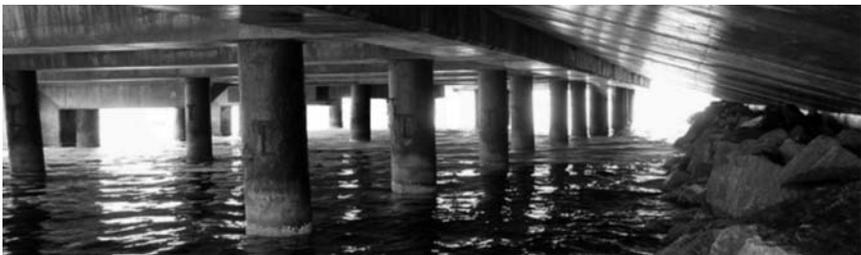
*Figure 1.2* Open concrete structures are still the most common type of harbour structure built along the Norwegian coastline.

In Norway where most of the offshore concrete construction has taken place so far, long traditions have existed on the utilization of concrete in the marine environment. Already in the early 1900s, the two Norwegian engineers Gundersen and Hoff developed and obtained their patent on the 'tremie method' for underwater placing of concrete during the building of the Detroit River Tunnel between the USA and Canada (Gjørsv, 1968). From 1910, when Gundersen came back to Norway and became the director of the new contracting company AS Høyer-Ellefsen, his new method for underwater placing of concrete became the basis for the construction of a new generation of piers and harbour structures all along the rocky shore of the Norwegian coastline (Gjørsv, 1968, 1970). These structures typically consist of an open reinforced concrete deck on top of slender, reinforced concrete pillars cast under water. Although the underwater cast concrete pillars have been successively replaced by driven steel tubes filled with concrete, this open type of concrete structure is still the most common harbour structure being constructed along the Norwegian coastline (Figure 1.2).

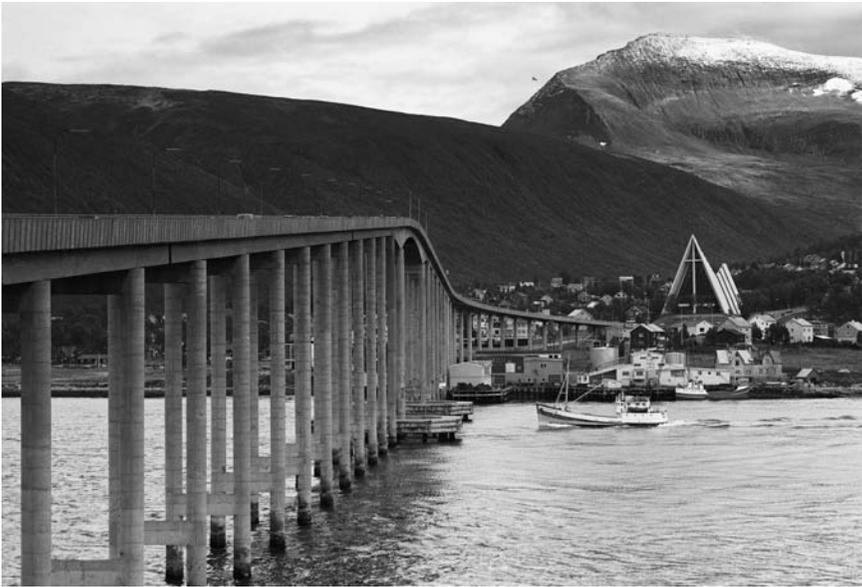
Figure 1.4 The Tromsø Bridge (1960) is a cantilever bridge with a total length of 1016 m (source: Courtesy of Johan Brun).

1990, 1994, 2001). In addition to conventional bridges (Figure 1.4), new concepts for strait crossings such as floating bridges (Figures 1.5 and 1.6) also emerged (Meaas *et al.*, 1994; Hasselø, 2001). Even submerged concrete tunnels have been the subject of detailed studies and planning, and one of several types of design is shown in Figure 1.7 (Remseth, 1997; Remseth *et al.*, 1999).

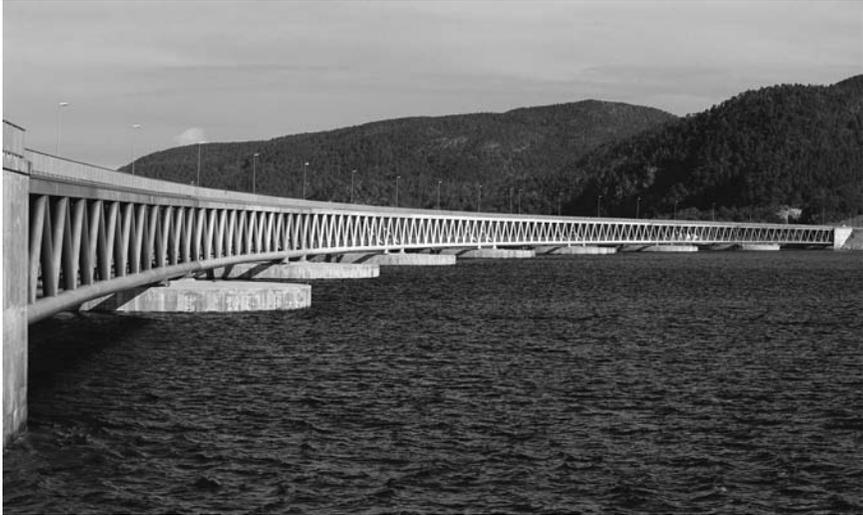
*Figure 1.5* The Bergsøysund Bridge (1992) is a floating bridge with a total length of 931 m (source: Courtesy of Johan Brun).

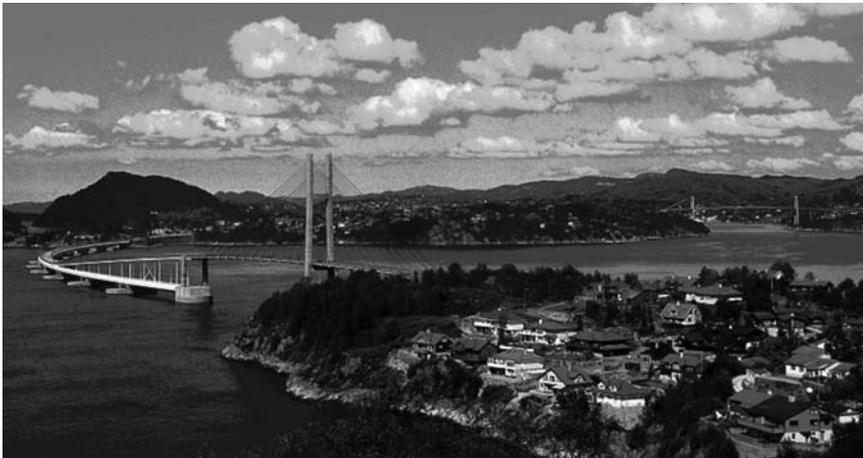
*Figure 1.6* The Nordhordlands Bridge (1994) is a combined floating and cable-stayed bridge with a total length of 1610 m (source: Courtesy of Johan Brun).

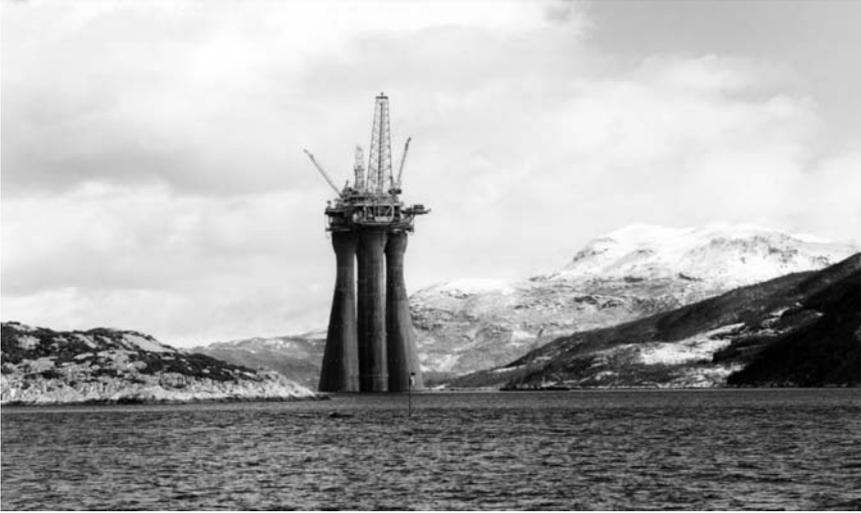
*Figure 1.12* After production in one of the deep Norwegian fjords, the Troll A Platform was ready to be towed out to the North Sea in 1995 (source: Courtesy of Jan Moksnes).

size of this structure. After production in one of the deep Norwegian fjords (Figure 1.12), the Troll A Platform containing 245,000 m<sup>3</sup> of high strength concrete, 100,000 t of reinforcing steel and 11,000 t of prestressing steel was moved out to its final offshore destination, and this operation was the biggest movement of a man-made structure ever carried out (Figure 1.13). In 1995, the Heidrun platform was also installed in deep water at a depth

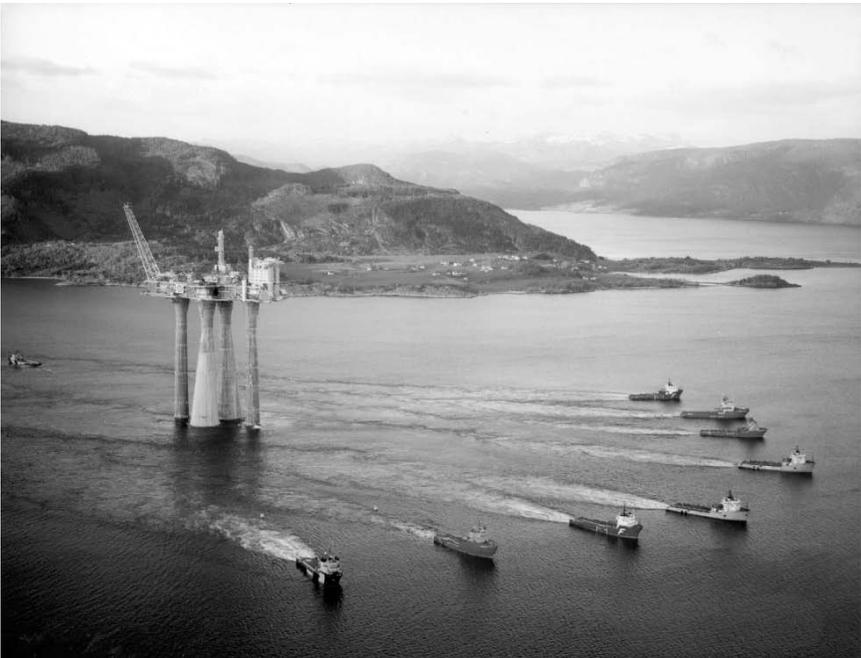
*Figure 1.13* The Troll A Platform (1995) on its way out to its final destination in the North Sea (source: Courtesy of Aker Solutions).

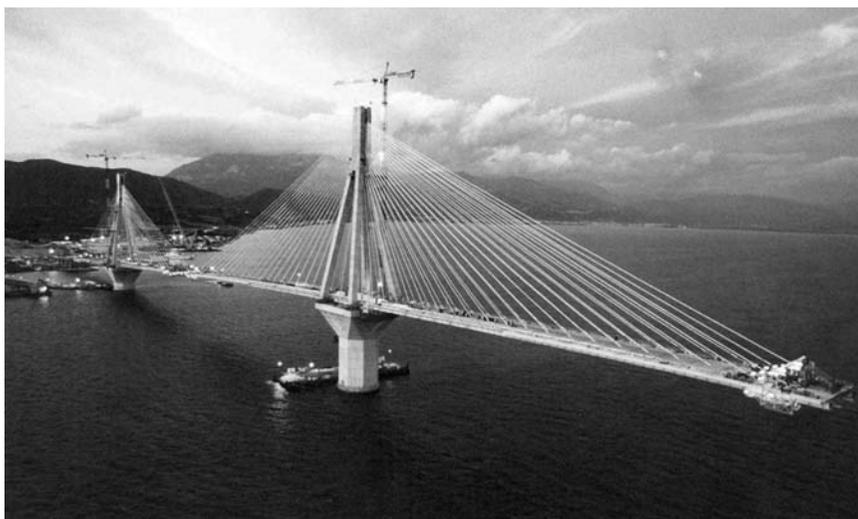
Figure 1.14 The Rion–Antirion Bridge (2001), to which a concrete with an extremely high resistance to chloride penetration was applied (source: Courtesy of Gefyra S.A.).

From the early 1970s, a rapid development of high strength concrete both for new offshore structures and a number of other types of structure took place (Gjørøv, 2008). Since high strength and low porosity would also enhance the overall performance of the material, the term ‘High Performance Concrete’ was successively introduced and specified for concrete durability rather than for concrete strength. As experience with this type of concrete was gained, however, it was discovered that specification of ‘High Performance Concrete’ was not necessarily good enough for ensuring high durability of concrete structures in severe environments. In recent years, therefore, a new and rapid development of more advanced procedures for durability design has taken place. As a result, new concrete structures with a more controlled and improved durability can now be produced. Thus, for the most exposed parts of the Rion–Antirion Bridge which was constructed in the southern part of Greece in 2001 (Figure 1.14), concrete with an extremely high resistance against chloride penetration was applied, giving a very high safety level against steel corrosion. This type of concrete, which was based on a blast furnace slag cement with a high slag content, showed a 28-day chloride diffusivity of  $0.8 - 1.2 \times 10^{-12} \text{ m}^2/\text{s}$  according to the RCM method (NORDTEST, 1999), with achieved values

for the chloride diffusivity on the construction site after one year of  $4.0 - 5.5 \times 10^{-13} \text{ m}^2/\text{s}$  (Kinopraxia Gefyra, 2001).

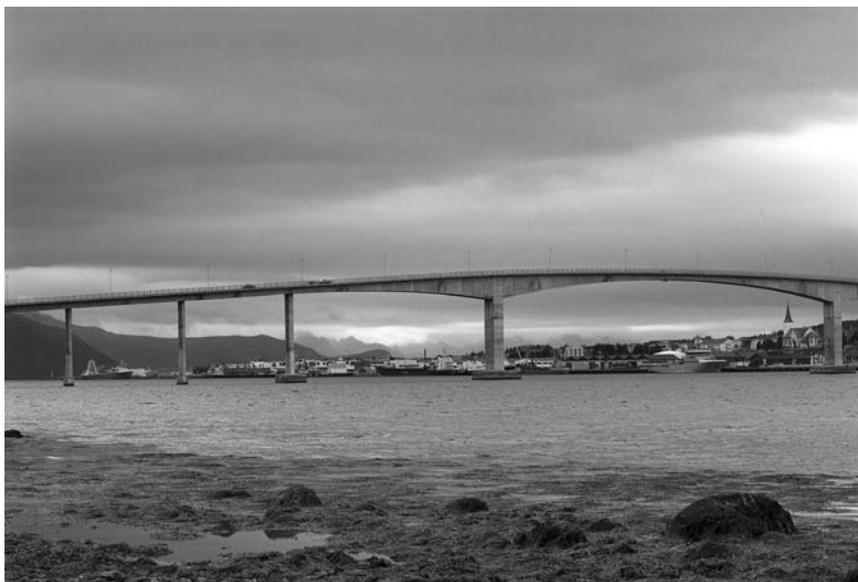
*Figure 2.1* The Sortland Bridge (1975) is a 948 m-long cantilever bridge in the northern part of Norway (source: Courtesy of Johan Brun).

For all the concrete structures in marine environments, the environmental conditions may be even more severe. Thus, along the Norwegian coastline, there are more than 300 concrete bridges and 10,000 harbour structures, most of which have been built from concrete (Figure 2.1). For many years, more than half of all these concrete bridges and most of the concrete harbour structures have been severely affected by corrosion of embedded steel (Østmoen *et al.*, 1993; Gjørsv, 1968, 1994, 1996, 2002, 2006). In addition, in the North Sea, a number of the offshore concrete structures have shown some extent of steel corrosion.

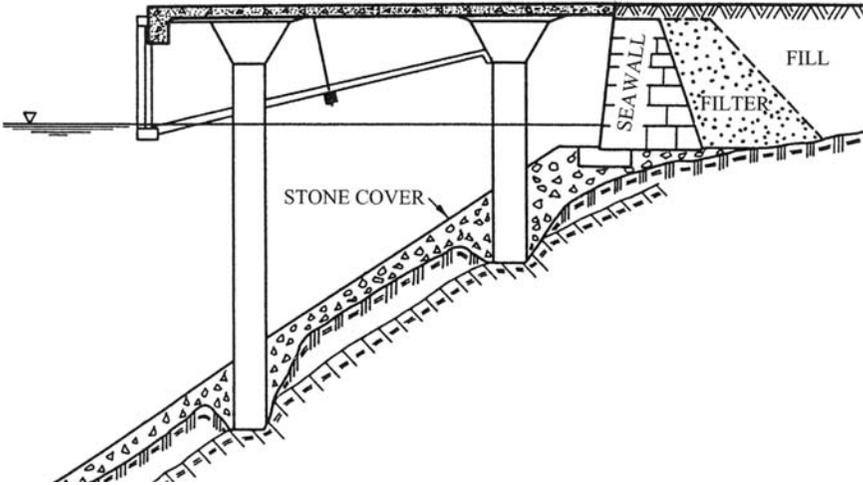
Figure 2.2 A section through an open concrete harbour structure with a reinforced concrete deck on top of slender, reinforced concrete pillars cast under water (source: Gjørnv (1968)).

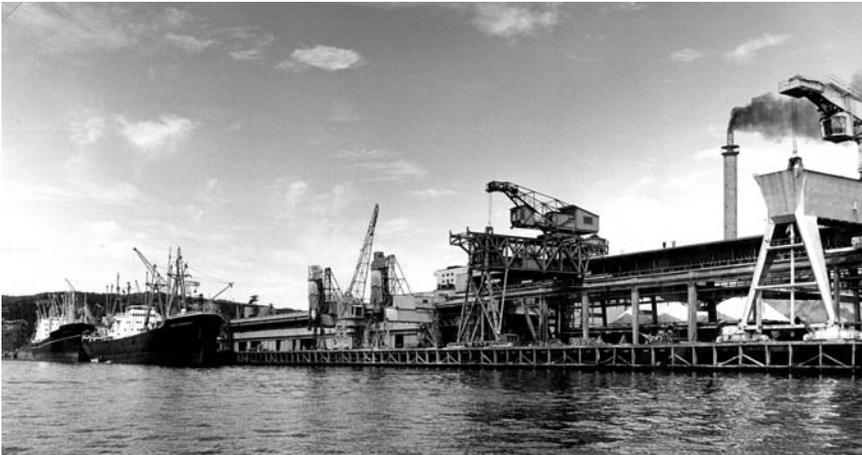
Figure 2.3 An industrial concrete harbour structure (source: Gjørnv (1968)).

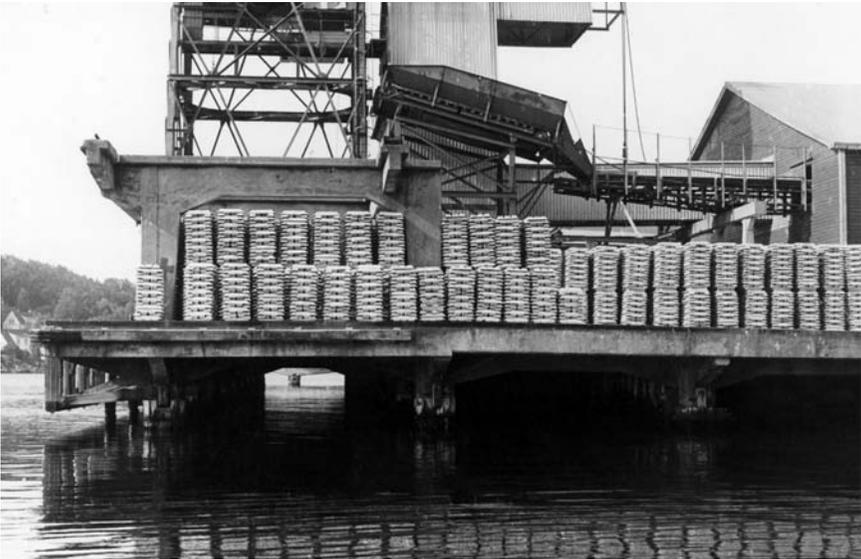
*Figure 2.6* A 50-year-old industrial harbour structure (1913) with storage of raw aluminium bars representing an evenly distributed deck load of approximately six times that of the original design load (source: Gjørnv (1968)).

shown in Figure 2.6. This deck load was approximately six times that of the original design load. Apart from severe corrosion in all the deck beams, no specific sign of any overloading was observed on this 50-year-old concrete harbour structure.

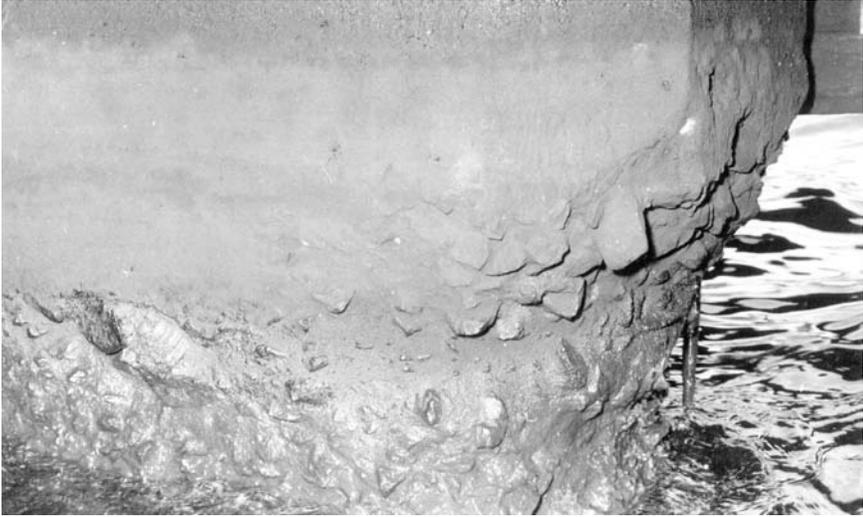
*Figure 2.7* Deterioration in the tidal zone mostly due to freezing and thawing (source: Gjørøv (1968)).

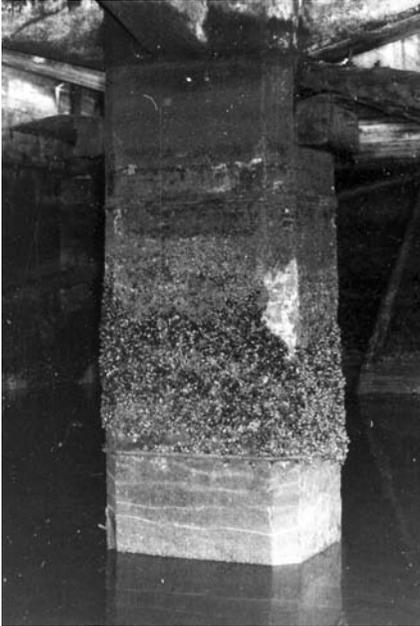
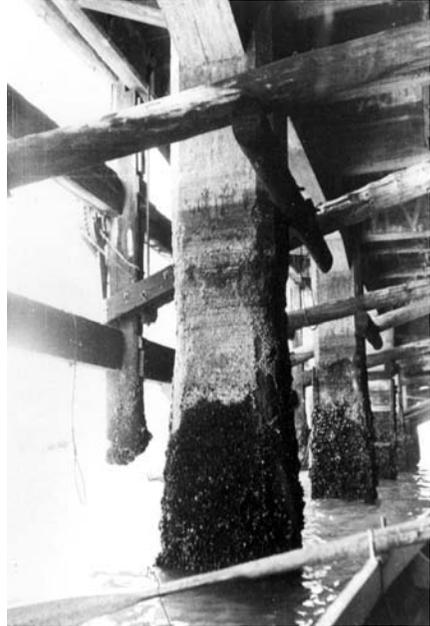
*Figures 2.8(a) and (b)* Tremie-cast concrete pillar (1929) in excellent condition after 34 years of freezing and thawing in Narvik Harbour (a) and 43 years in Glomfjord Harbour (1920) (b) (source: Gjørøv (1968)).

Even after many years of freezing and thawing, the overall condition of the concrete pillars was very good. Even in the northern part of Norway with high amounts of frost and tidal waters of up to 2 or 3 m, a very good condition was observed after 30 or 40 years (Figures 2.8(a) and (b)). For those pillars with observed deterioration, the damage was mostly very local, demonstrating a high variability in concrete quality from one pillar to another (Figure 2.9). For most of the concrete pillars, however, the con-

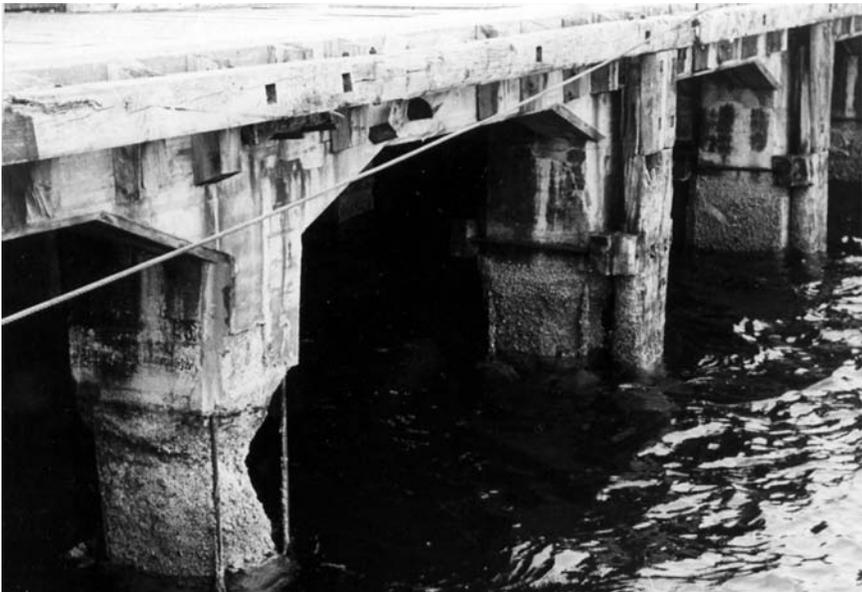
*Figure 2.9* Uneven deterioration in the tidal zone due to the high variability of concrete quality from one pillar to another (source: Gjørøv (1968)).

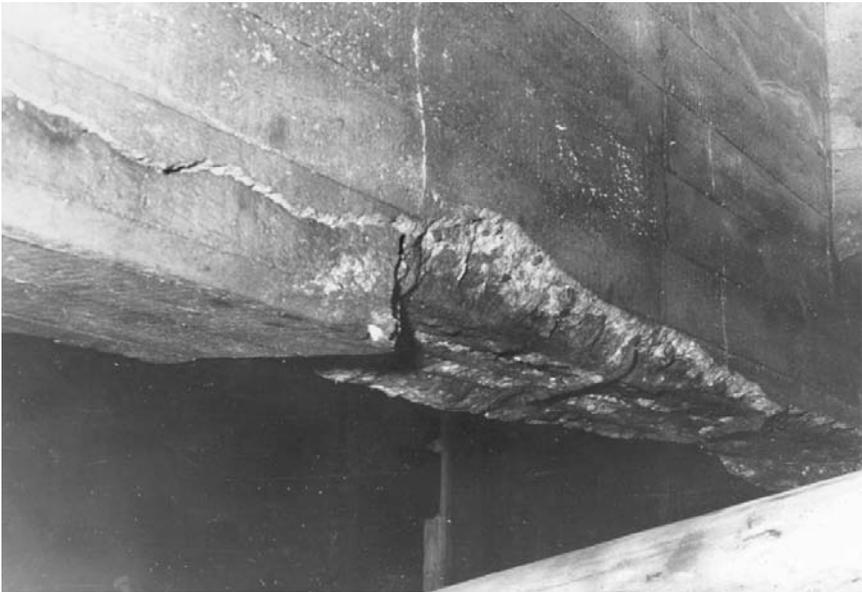
*Figure 2.10* The lower parts of the deck beams were more vulnerable to steel corrosion than the deck slabs in between (source: Gjørv (1968)).

such as the deck beams would always absorb and accumulate more chloride and hence develop anodic areas, while the less exposed parts such as the slab sections in between would act as catchment areas for oxygen and hence form cathodic areas. As a consequence, the more exposed parts of the deck such as beams and girders would always be more vulnerable to steel corrosion compared to the rest of the concrete deck. This was also the reason why the rear parts of the concrete deck close to the seawall would be more vulnerable to steel corrosion than the rest of the concrete deck (Figure 2.11).

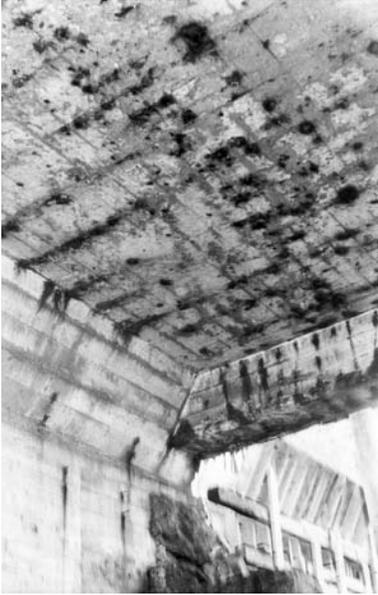
*Figure 2.11* The rear parts of the concrete deck adjacent to the seawall were more vulnerable to steel corrosion than the rest of the deck (source: Gjrv (1968)).

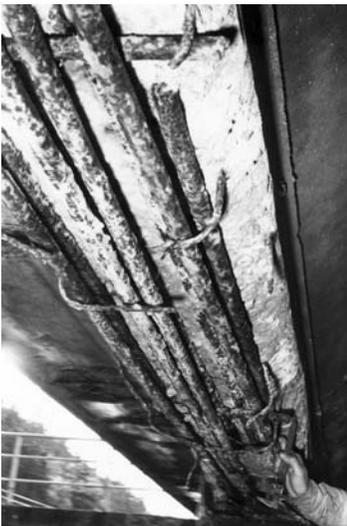
*Figure 2.12* When the concrete cover in the lower parts of the deck beams had cracked or spalled off at a very early stage, the steel bars were more uniformly corroded, while the protruding beam stirrups always showed a more pitting-type of corrosion (source: Gjrv (1968)).

Above water, more than 80 per cent of all the concrete structures had a varying extent of damage due to steel corrosion, and, in those structures which were observed without any damage, repairs due to steel corrosion had recently been carried out. The first visible sign of steel corrosion in the form of rust staining and cracks typically appeared after a service period of five to ten years, and it was primarily those parts of the structures which had been the most exposed to intermittent wetting and drying which were the most vulnerable to corrosion. Typically, this included the lower parts of the deck beams (Figure 2.10) and the rear parts of the concrete decks adjacent to the seawall (Figure 2.11). When the concrete cover in the lower parts of the deck beams had cracked or spalled off at a very early stage, it was typically observed that the longitudinal bars appeared to be more uniformly corroded, while the protruding beam stirrups showed a more severe pitting-type of corrosion and were mostly rusted through (Figure 2.12).

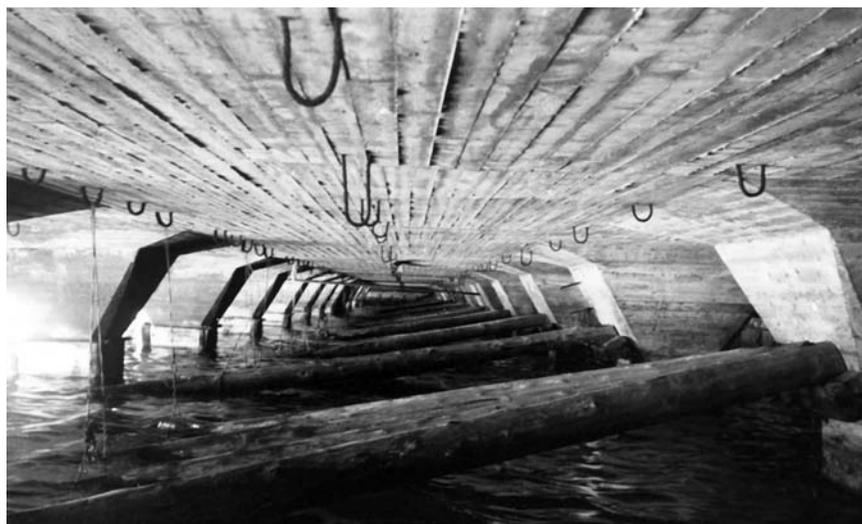
Figure 2.13 Harbour structures with a concrete deck of the flat type showed a much better performance than structures with a beam and slab type of deck (source: Gjørø (1968)).

Prior to 1930, experience had shown that the slabs of the open concrete decks had performed much better than the deck beams. This was assumed to be due to an easier and better placing and compaction of the fresh concrete in the deck slabs compared to that of the deep and narrow beams and girders. The practical consequence of this was drawn in 1932, when the first flat type of concrete deck was introduced into Norwegian harbour construction. From then on, a number of structures with a flat type of concrete deck were constructed, and these structures demonstrated a far better long-term performance than those with the beam and slab type of deck (Figure 2.13). Since such a structural design was often more expensive, however, the slab and beam type of deck was gradually reintroduced. It was assumed that if the beams were made shallower and wider, it would be equally easy to place the fresh concrete in such structural elements. After some time, however, even the shallower and wider deck beams showed early corrosion, while the flat type of concrete deck without any beams still performed much better.

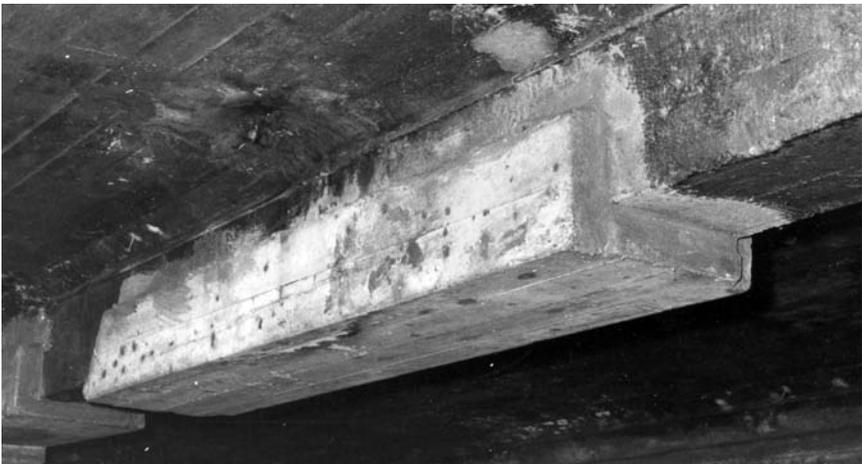
Figure 2.14 Typical patch repair of a corroded deck beam (source: Gjørnv (1968)).

The extensive repair work carried out due to steel corrosion in the deck beams also showed a very short service life, mostly under ten years. Typically, the corroded steel in the locally spalled areas had first been cleaned and then locally patched with new concrete as is shown in Figure 2.14. In addition, what was not known in these early days was that such a local patch repair would always cause localized changes in the electrolytic conditions and thus variations in the electrochemical potentials along the steel. As a result, accelerated corrosion adjacent to the local patch repair would develop, the result of which is demonstrated in Figure 2.15. This detrimental effect of patch repairs was first observed and systematically reported by Stratfull in the early 1950s (Gewertz *et al.*, 1958).

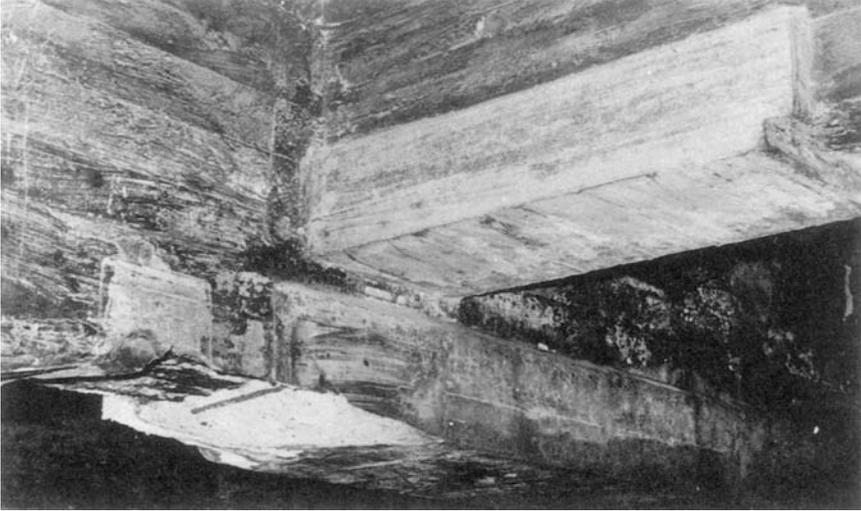
Figure 2.15 Accelerated corrosion adjacent to the local patch repair of a deck beam (source: Gjrv (1968)).

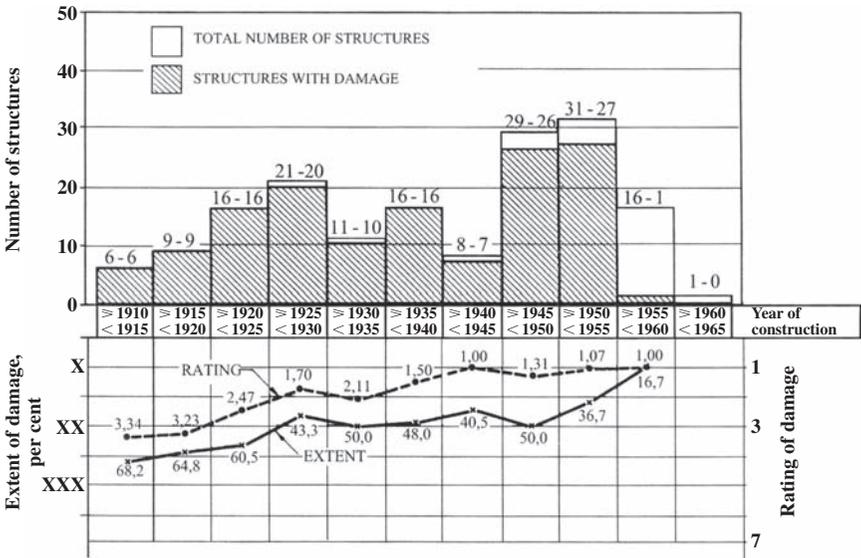
Figure 2.16 Trends in the development of deterioration due to steel corrosion in deck beams (source: Gjrv (1968)).

Although extensive steel corrosion had been going on in all the deck beams throughout most of the service life of this particular jetty, the overall condition of the structure was relatively good even after a service period of more than 60 years. In spite of the extensive visible corrosion damage and deep chloride penetration beyond the embedded steel throughout the whole concrete deck, the demolition revealed that most of the rebars were still in quite good condition, and practically without any visible corrosion. This made up more than about 75 per cent of the total reinforcing steel system. For the rest of the reinforcement, which was mostly located in the lower part of the deck beams, the observed corrosion was very unevenly distributed and quite severe. However, in the lower parts of the deck beams, the cross-section of the bars was seldom reduced by more than 30 per cent, while for the rest of the rebar system, most of the steel bars had reduced cross-sections of less than 10 per cent. The best condition of the rebar system was observed in the deck slabs. These observations demonstrate how efficiently the corroding steel in the lower part of the deck beams had functioned as sacrificial anodes and thus cathodically protected the rest of the rebar system. This protective effect of the most corroding parts of the rebar system may also explain the relatively slow reduction in the structural capacity of all the structures previously investigated (Figure 2.16).

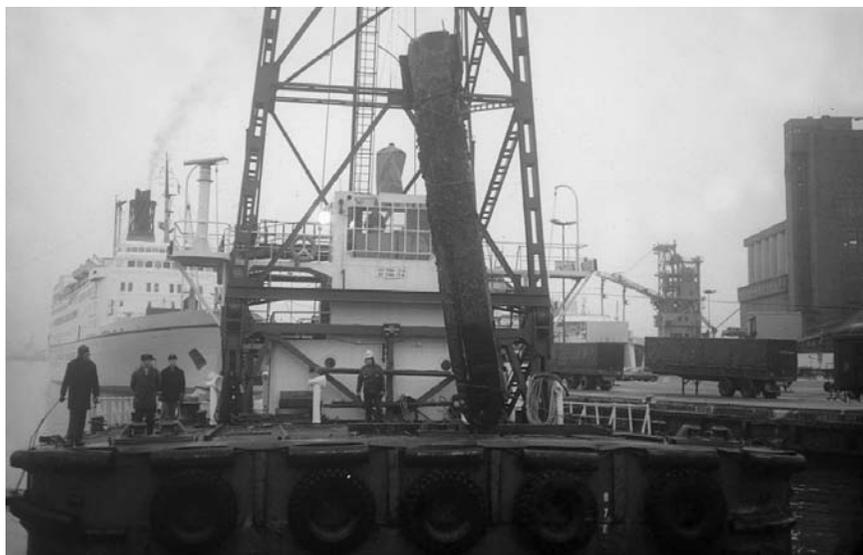
*Figure 2.18* Four of the tremie-cast concrete pillars from the concrete jetty in Oslo Harbour (1922) were pulled up on shore for a more detailed investigation.

The four tremie-cast concrete pillars which were pulled up on shore showed a very good overall condition. A number of concrete cores showed

compressive strengths of 40 to 45 MPa. Upon removal of the concrete cover, the embedded steel in the continuously submerged parts of the pillars showed a very good overall condition, mainly due to lack of oxygen. Above the low-water level, 1 mm-deep pittings on the individual bars were typically observed, while below this level the pittings were mostly under 0.2 mm and only occasionally as much as 0.5 mm.

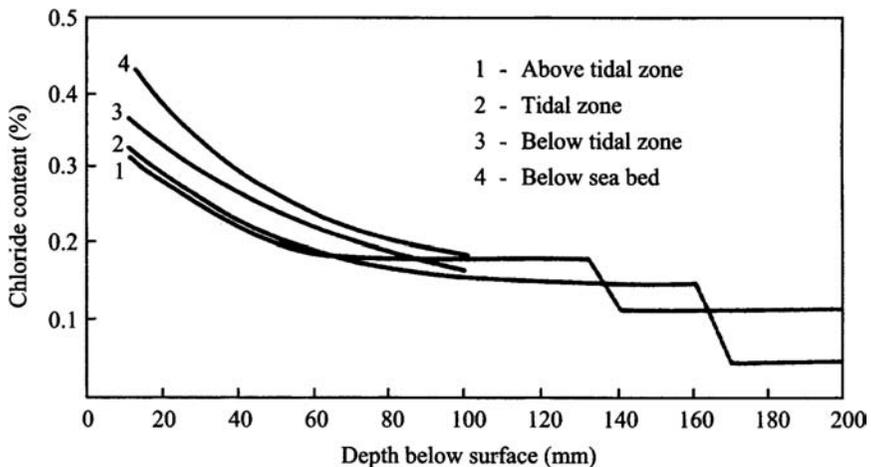
Figure 2.19 Penetration of chloride into the tremie-cast concrete pillars after 61 years of exposure (source: Gjrv and Kashino (1986)).

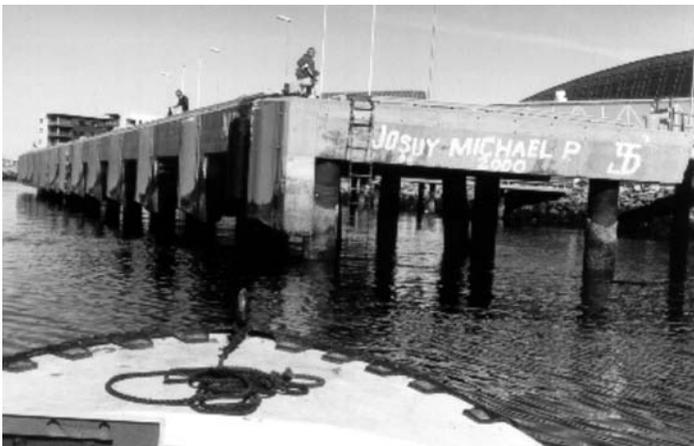
Figure 2.20 'Turistskipskaia' (1993) in Trondheim Harbour with steel corrosion in most of the deck beams after eight years of exposure (source: Gjrv (2002)).

In Trondheim Harbour, steel corrosion in most of the deck beams of a concrete jetty from 1993 after eight years of service was observed (Figure 2.20). According to the Norwegian Concrete Code NS 3420 (Standard Norway, 1986), a concrete quality with a compressive strength of 45 MPa and maximum water/binder ratio of 0.45 had been specified, and this had also been achieved by use of a concrete based on 380 kg/m<sup>3</sup> high performance portland cement and 19 kg/m<sup>3</sup> silica fume (5 per cent). During the field investigations after eight years of service, removed concrete cores showed an average chloride diffusivity according to the RCM method (NORDTEST, 1999) of  $10.7 \times 10^{-12} \text{ m}^2/\text{s}$ , which indicates only a moderate resistance against chloride penetration. Since an average concrete cover in the deck beams of approximately 50 mm was observed, the specified

minimum concrete cover of 40 mm according to Norwegian Concrete Code NS 3473 (Standard Norway, 1989) had also been achieved. Nevertheless, visual observations, detailed mapping of electrochemical surface potentials and extensive chloride penetration measurements revealed a varying extent of steel corrosion in all the deck beams of the structure. After approximately eight years of exposure, the chloride front had mostly reached a depth varying from 40 to 50 mm, as shown in Figure 2.21.

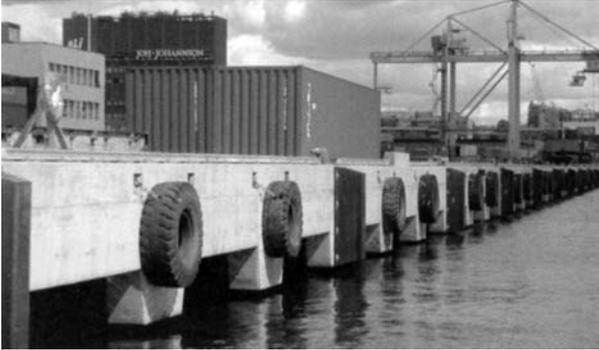
Figure 2.27 During construction of ‘Nye Filipstadkaia’ (2002) in Oslo Harbour, deep chloride penetration in several of the deck beams took place due to heavy winds and high tides (source: Courtesy of Oslo Harbour KF).

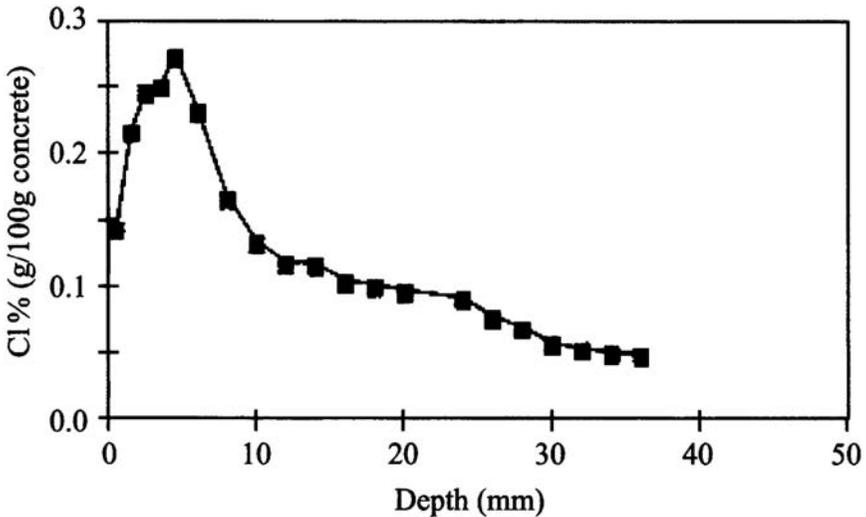
Figure 2.28 Observed chloride penetration in the deck beams during concrete construction of ‘Nye Filipstadkaia’ (2002) in Oslo Harbour (source: Gjrv (2002)).

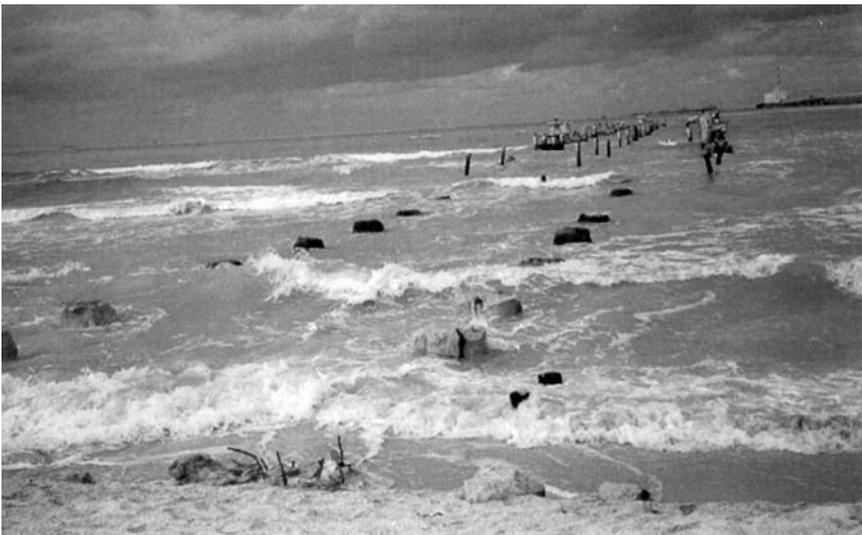
Figure 2.29 Remaining parts of a concrete pier built in a conventional way on the Yucatán Coast in Mexico in the 1960s (source: Courtesy of Rambøll Consulting Engineers).

In many countries, high temperatures may enhance the durability problems due to increased rates of deterioration. Thus, in the Persian Gulf countries, quite extreme durability problems are being experienced (Matta, 1993; Alae, 2000). Similar problems have been reported from a number of other countries with hot climates. This is clearly demonstrated in the Progreso Port on the Yucatn Coast in Mexico, as is shown in Figures

2.29–2.32. Due to very shallow waters, two long piers were constructed in order to provide proper harbour facilities. Of the pier constructed in a conventional way in the 1960s, only small parts of the structure still remained, while the neighbouring pier, which was constructed during 1937 to 1941 with stainless steel reinforcements, was still in very good condition when it was investigated in 1998 (Knudsen and Skovsgaard, 1999). None of the concrete qualities in these two piers was very good. After a service period of approximately 60 years, however, detailed field investigations of the old pier showed that the embedded steel ( $\text{Ø}30\text{mm}$ ) was still in very good condition in spite of high chloride content adjacent to the steel, typically varying from 0.6 to 0.7 per cent by weight of concrete at depths of 80 to 100mm below the concrete surface (Rambøll, 1999).

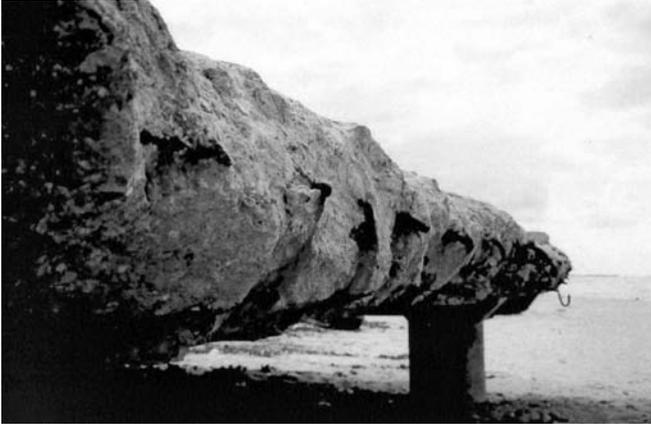
*Figure 2.30* Remaining part of the deck from the concrete pier built on the Yocatán Coast in the 1960s (source: Courtesy of Rambøll Consulting Engineers).

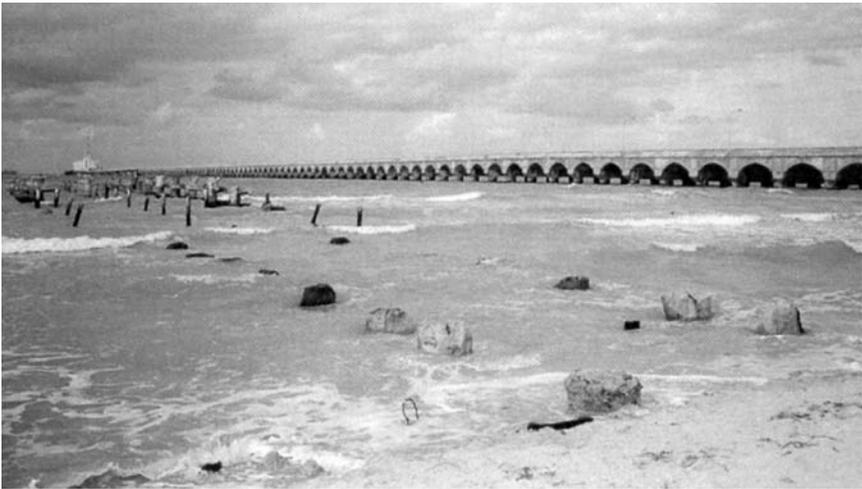
*Figure 2.31* Different durability and long-term performance of the two concrete piers on the Yocatán Coast built with black steel in the 1960s (front) and with stainless steel during 1937–1941, respectively (source: Courtesy of Rambøll Consulting Engineers).

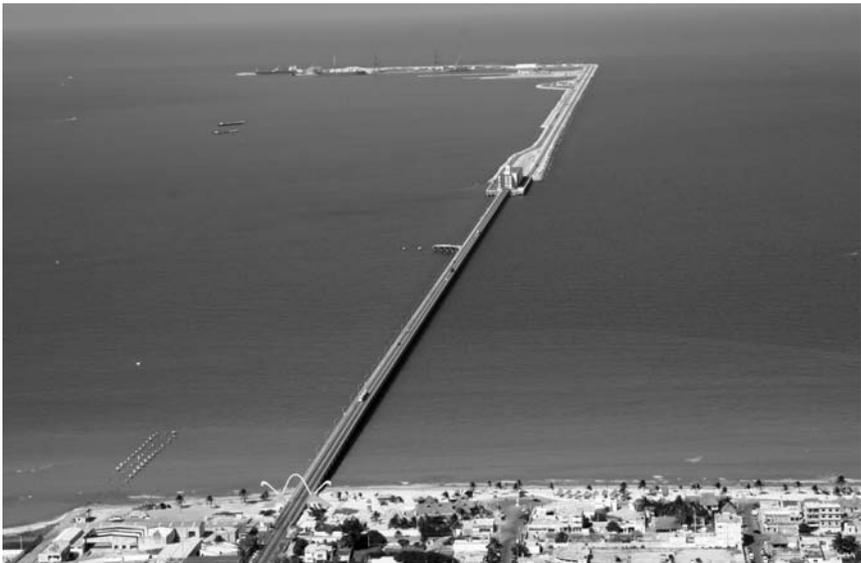
*Figure 2.33* Overview of the Progreso Pier on the Yucatán Coast in Mexico (source: Courtesy of Progreso Port Authorities).

In more recent years, the old Progreso Pier has been further extended into deep waters (Figure 2.33), so that it now provides port facilities for heavy traffic with a variety of different types of ship (Figure 2.34). Before the old pier was constructed in the late 1930s, it was considered by the owner to be of vital importance to keep this pier in safe operation with as little interruption as possible. Therefore, the owner was willing to pay the additional costs for having a structure with as high durability as possible. Hence, this project clearly demonstrates how the additional costs of stainless steel later on have proved to be an extremely good investment for the owner (Progreso Port Authorities, 2008).

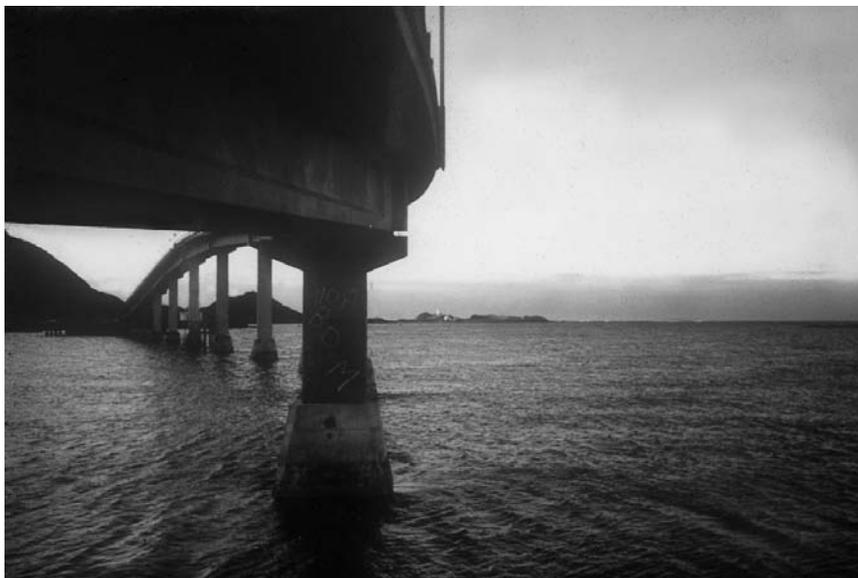
*Figure 2.35* Ullasundet Bridge (1970) was demolished after 25 years of service due to heavy corrosion of embedded steel (source: Courtesy of Jørn A. Hasselø).

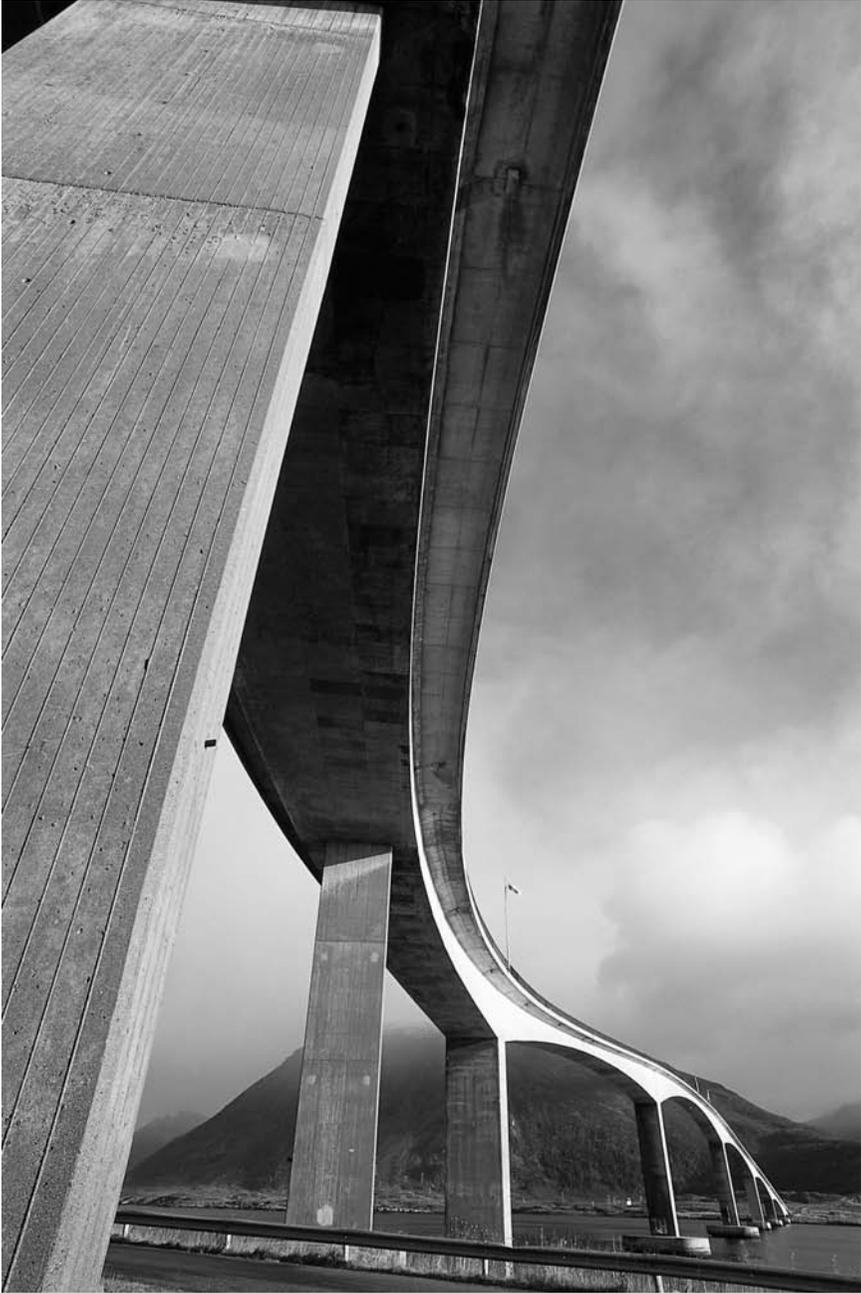
*Figure 2.36* Gimsøystraumen Bridge (1981) which was the most common type of Norwegian concrete coastal bridge from the 1970s and 1980s (source: Courtesy of Johan Brun).

For most of the corroding bridges along the Norwegian coastline, large amounts of chloride had penetrated the concrete far beyond the level of the reinforcing steel after a relatively short period of service. Thus, for the Gimsøstraumen Bridge (Figure 2.36), which is the most common type of Norwegian coastal bridge from the 1970s and 1980s, the heavily corroding bridge was the subject of an extensive research programme carried out by the Norwegian Public Roads Administration during the period 1993 to 1997. The objective of this research programme was primarily to investi-

For the superstructure of Gimsøystraumen Bridge, concrete with a compressive strength of 40 MPa and a minimum concrete cover of 30 mm had been specified. Although such a specified concrete cover was very small for a bridge in such an environment, the achieved concrete cover observed later on was even smaller due to poor workmanship and lack of proper quality control during concrete construction. This is clearly demonstrated in Figure 2.40, where the results of more than 2028 single measurements of concrete cover during the extensive field investigations are shown.

For the Gimsøystraumen Bridge, the observed moisture content in the outer 40 to 50 mm of the concrete was typically very high, with relative humidities in the range of 70 to 80 per cent corresponding to a degree of

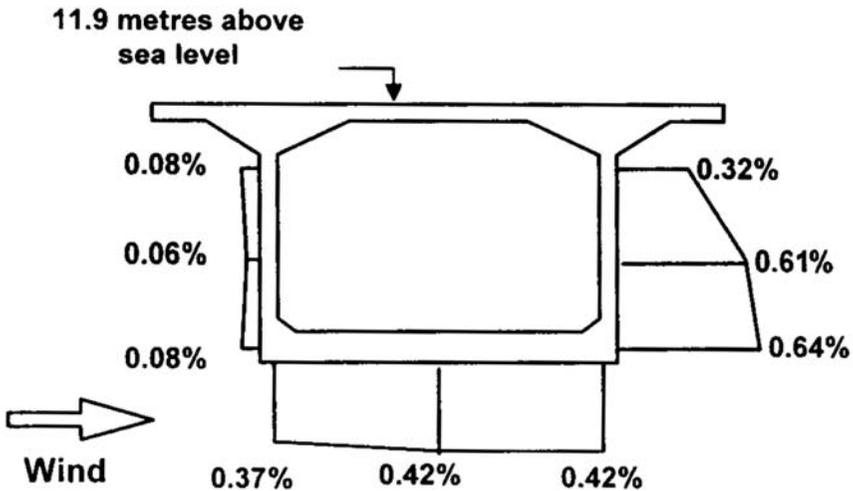
Figure 2.38 Gimsøystraumen Bridge (1981) with the deepest chloride penetration typically observed in those parts of the bridge which were the least exposed to prevailing winds and salt spray (source: Fluge (1997)).

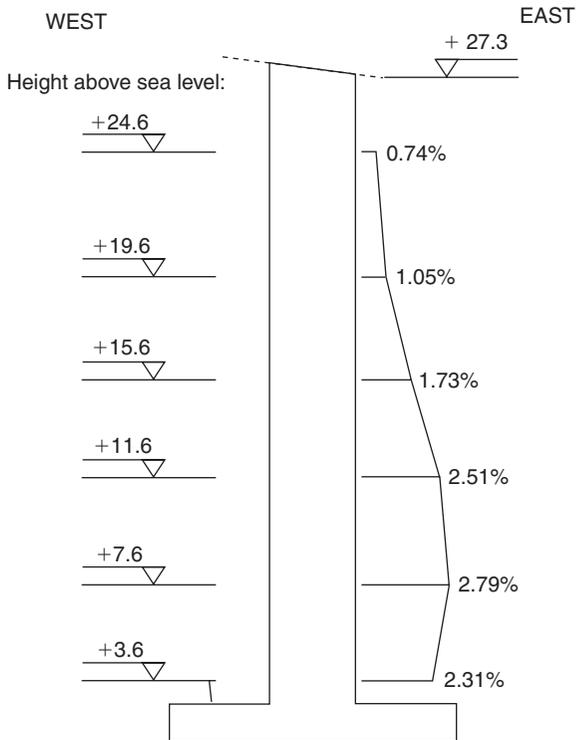
Figure 2.39 Gimsøystraumen Bridge (1981) with typical variation of chloride penetration above sea level (source: Fluge (1997)).

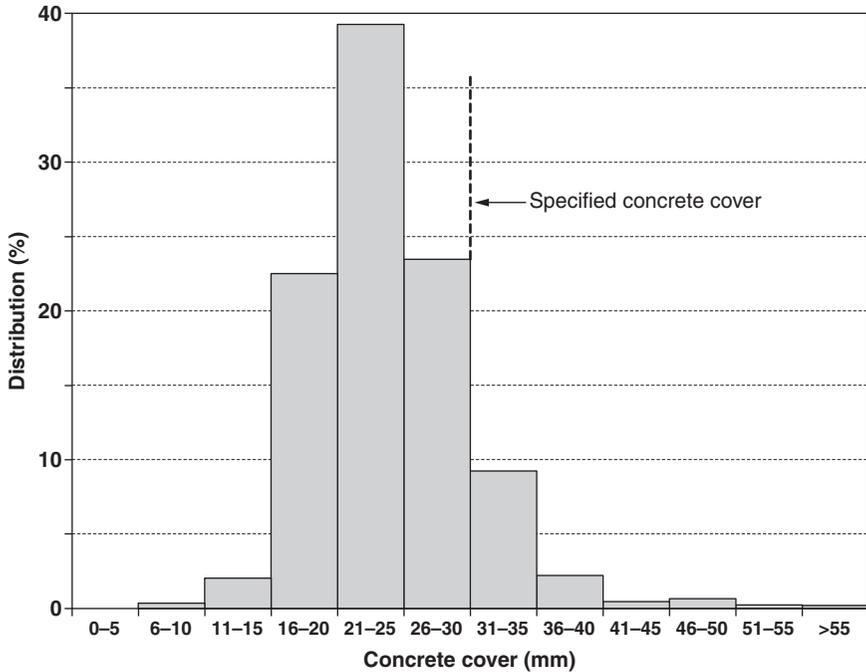
Figure 2.40 Gimsøystraumen Bridge (1981) with observed variation of achieved concrete cover (source: Kompén (1998)).

Figure 8.1 Variation in achieved concrete cover (mm) in the Gimsøystraumen Bridge (N) previously shown in Figure 2.40 compared to that of a Japanese bridge (J) and more than 100 concrete structures in the Gulf Region (GR) (source: Kompen (1998)).

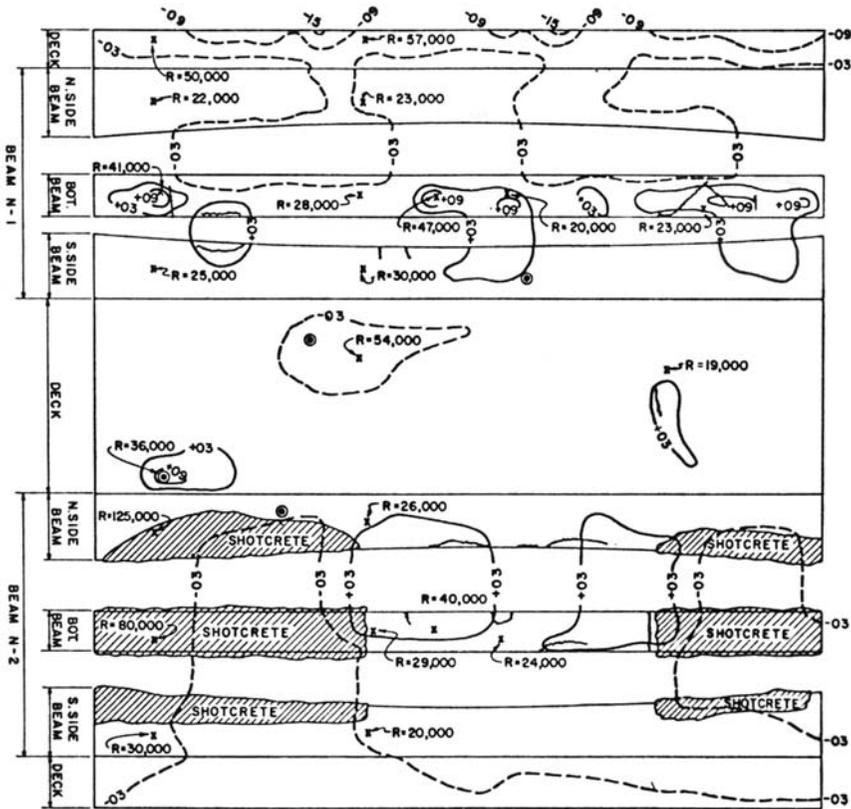
Figure 2.41 Equipotential contours demonstrating how the local patch repairs by shotcreting had typically formed a pattern of anodic areas (solid lines) and cathodic areas (dotted lines) along the concrete surface of the San Mateo-Hayward Bridge (1929) (source: Gewertz *et al.* (1958)).
