# DURABILITY DESIGN OF CONCRETE STRUCTURES IN SEVERE ENVIRONMENTS

**ODD E. GJØRV**

Taylor & Francis

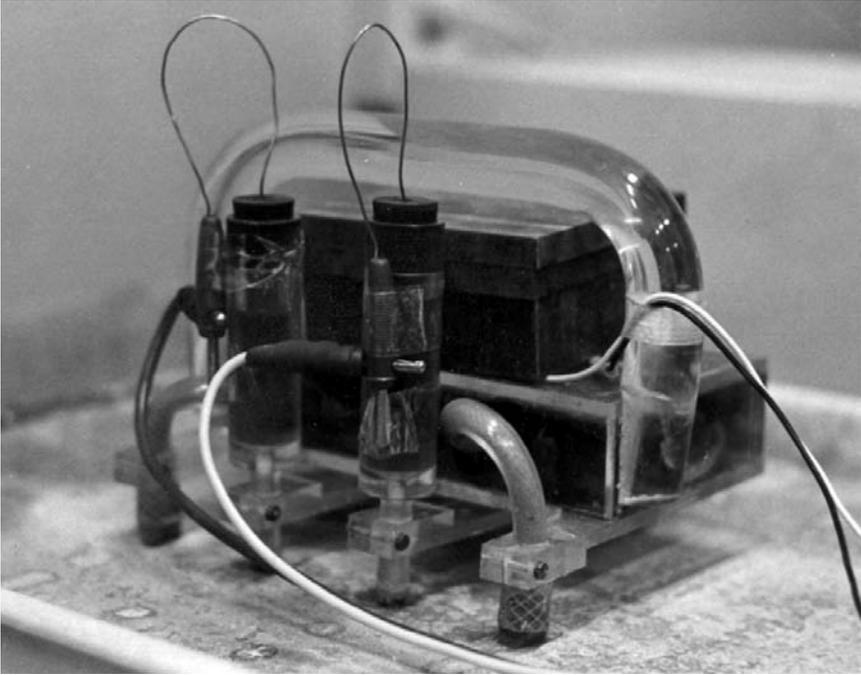
*Figure 2.42* The four-electrode (Wenner) device designed by Stratfull in the early 1950s for field measurements of electrical resistivity along the concrete surface of the San Mateo–Hayward Bridge (1929) (source: Stratfull (1970)).

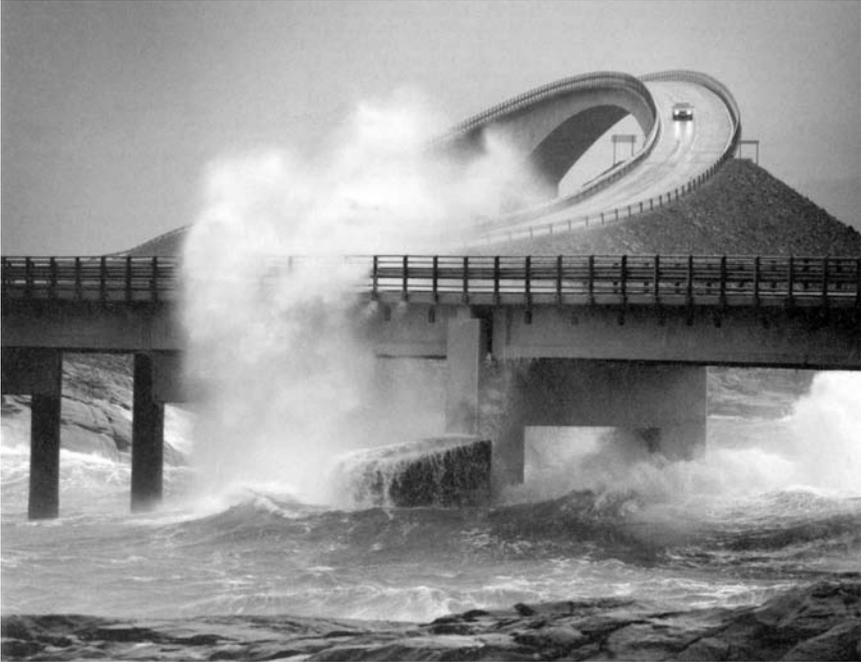
*Figure 2.45* During stormy winter days, the Storseisund Bridge (1988) is heavily exposed and partly covered by seawater (source: Courtesy of Johan Brun).

highway is a very pleasant and popular tourist route (Figure 2.44), but during stormy winter days, these bridges are heavily exposed and partly covered by seawater, as is shown in Figure 2.45.

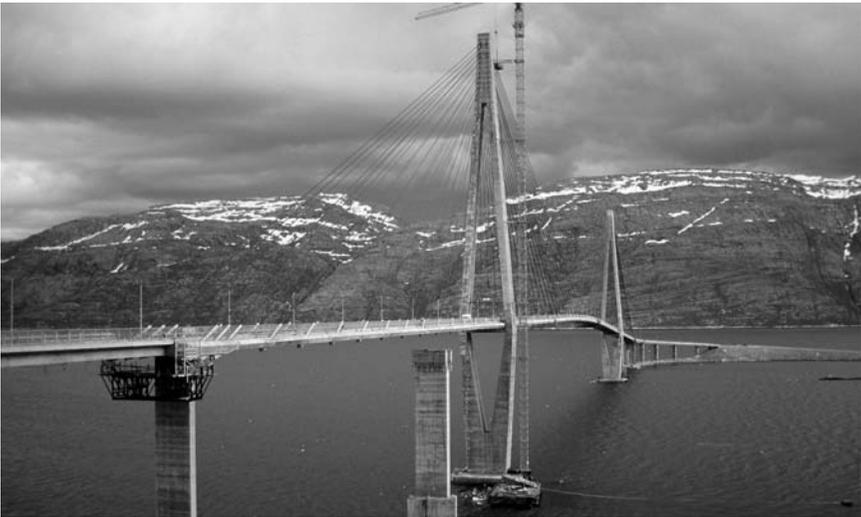
*Figure 2.46* The Helgeland Bridge (1991) is a 1065 m-long cable-stayed bridge with the largest span of 425 m (source: Courtesy of Hallgeir Skog).

For the 1065 m-long cable-stayed Helgelands Bridge (Figure 2.46) built in 1991 further north along the Norwegian coastline, a deep chloride penetration was observed already shortly after completion of the bridge (Figure 2.47). During the construction, however, parts of the bridge were heavily exposed to severe weather conditions and splashing of seawater before the concrete had gained sufficient maturity and density (Figures 2.48(a) and (b)).

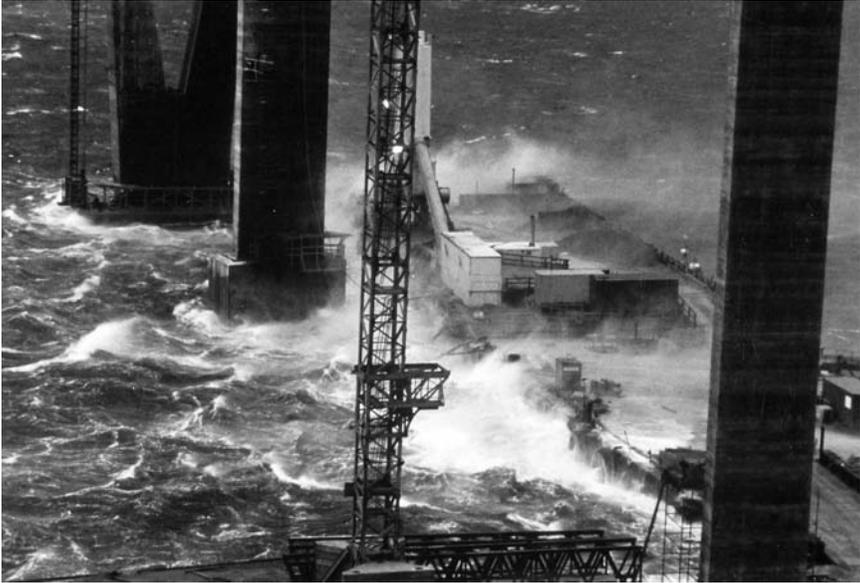
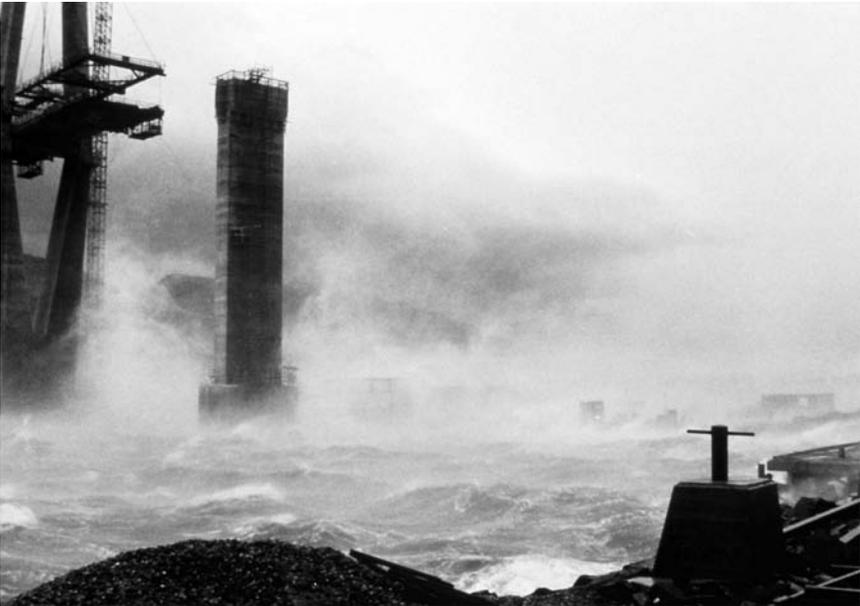
*Figures 2.48(a) and (b)* During concrete construction, parts of the Helgelands Bridge (1991) were heavily exposed to severe weather conditions and splashing of seawater (source: Courtesy of Hallgeir Skog).

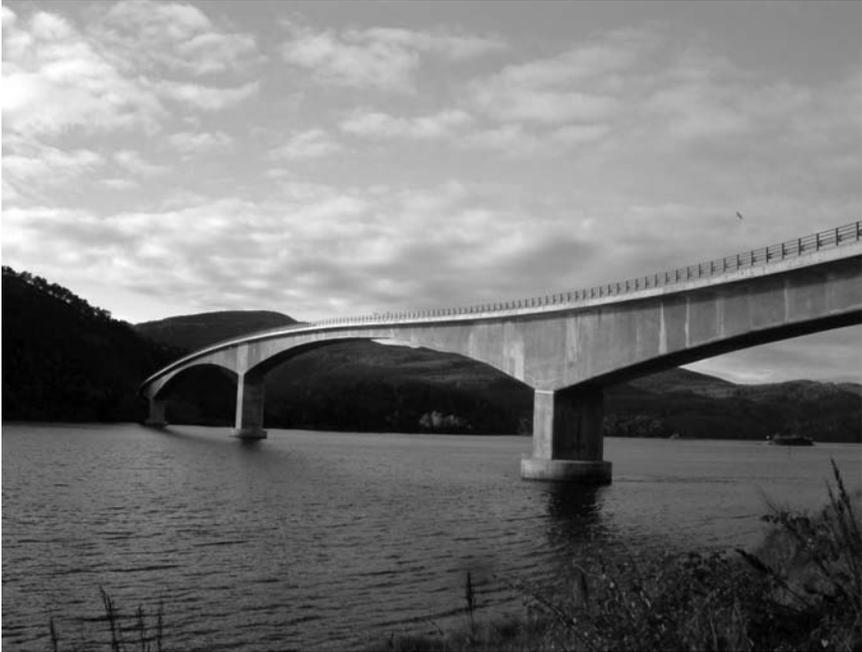
Figure 2.49 The Aursundet Bridge (1995) is a cantilever bridge with a total length of 486 m.

In order to gain experience for increased durability of new concrete bridges along the Norwegian coastline, the Norwegian Public Roads Administration decided subsequently on an experimental basis to further increase both concrete quality and concrete cover in a new bridge to be built at Aursundet on the west coast of Norway. Thus, when the Aursundet Bridge was built between 1993 to 1995 (Figure 2.49), a concrete based

on  $400\text{kg/m}^3$  of portland cement with  $50\text{kg/m}^3$  of silica fume (12.5 per cent) giving a water/binder ratio of 0.40 was applied. This concrete, which showed a 28-day compressive strength of 55 MPa, was combined with a minimum concrete cover of 80 mm in the splash zone. Ten years on, field investigations revealed average chloride penetrations in the eastern and

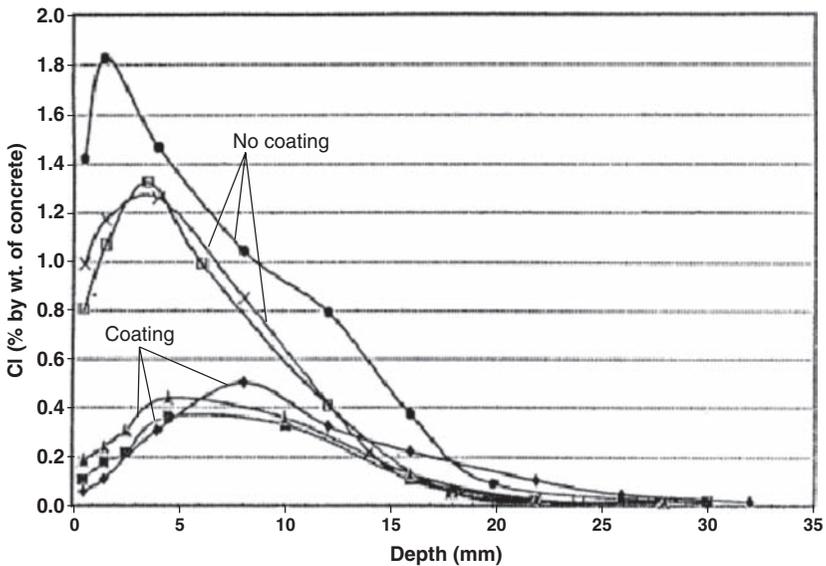
Figure 2.55 Effect of surface coating on chloride penetration in the Heidrun Platform (1995) after two years of exposure (source: Gjørøv (2002)).

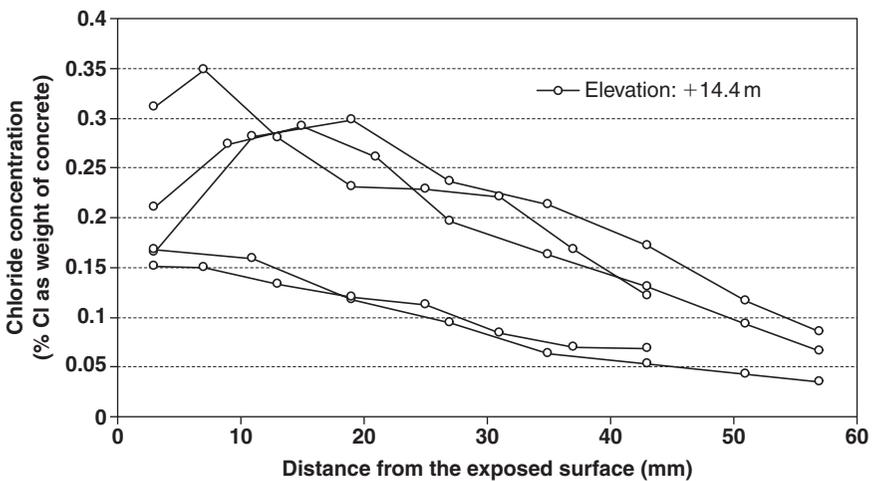
Figure 2.56 The Brent B Platform (1975) with observed chloride penetration at elevation +14.4m above water after 20 years of exposure (source: Sengul and Gjørvi (2007)).

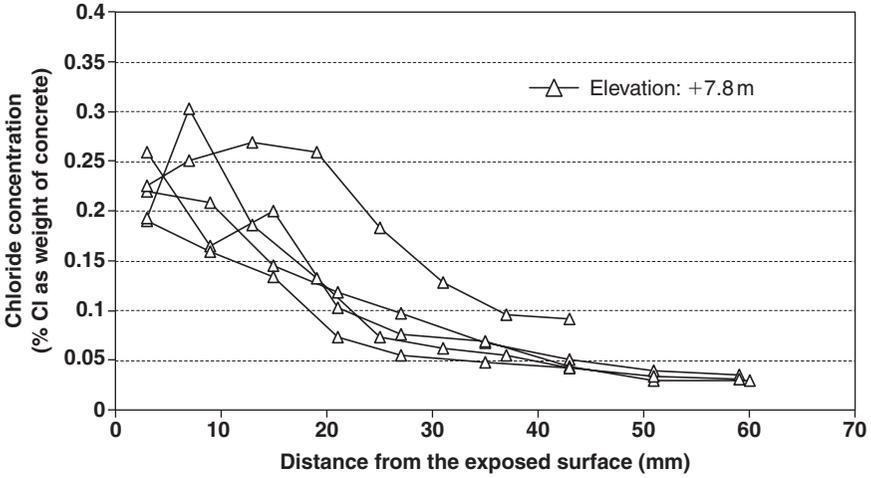
Figure 2.57 The Brent B Platform (1975) with observed chloride penetration at elevation +7.8 m above water after 20 years of exposure (source: Sengul and Gjrrv (2007)).

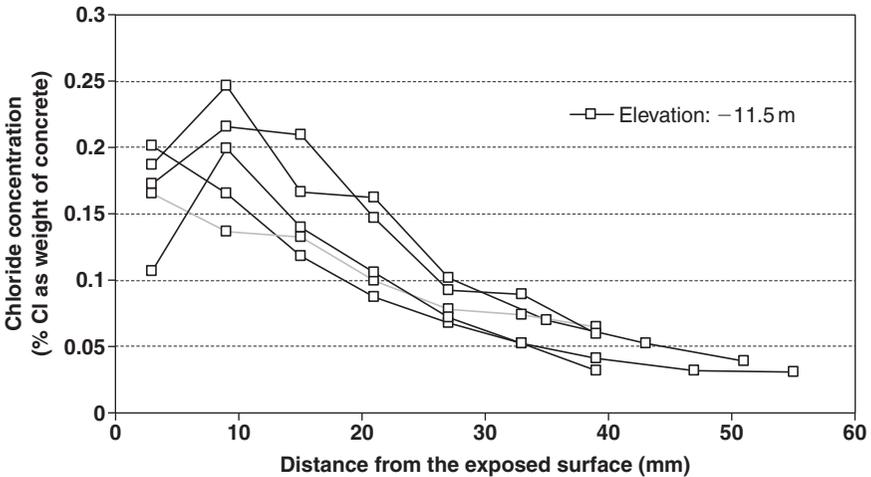
Figure 2.58 The Brent B Platform (1975) with observed chloride penetration at elevation -11.5 m below water after 20 years of exposure (source: Sengul and Gjrrv (2007)).

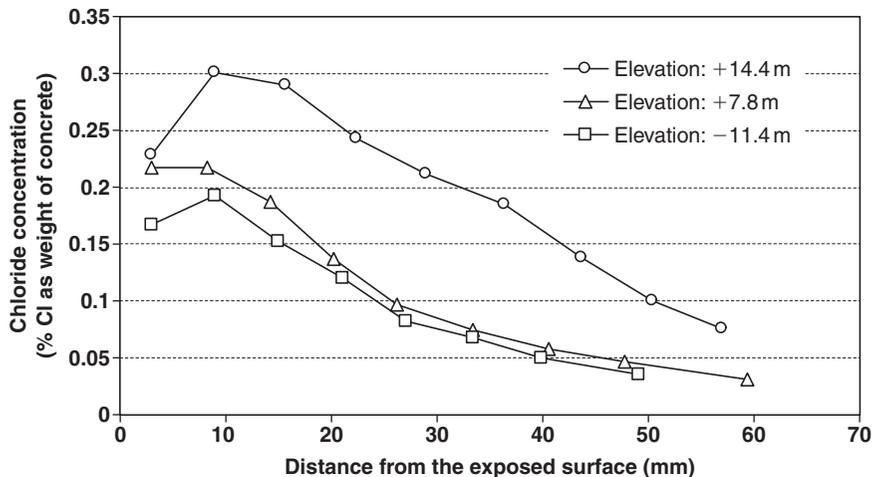
Figure 2.59 The Brent B Platform (1975) with observed chloride penetration after 20 years of exposure (source: Sengul and Gjrv (2007)).

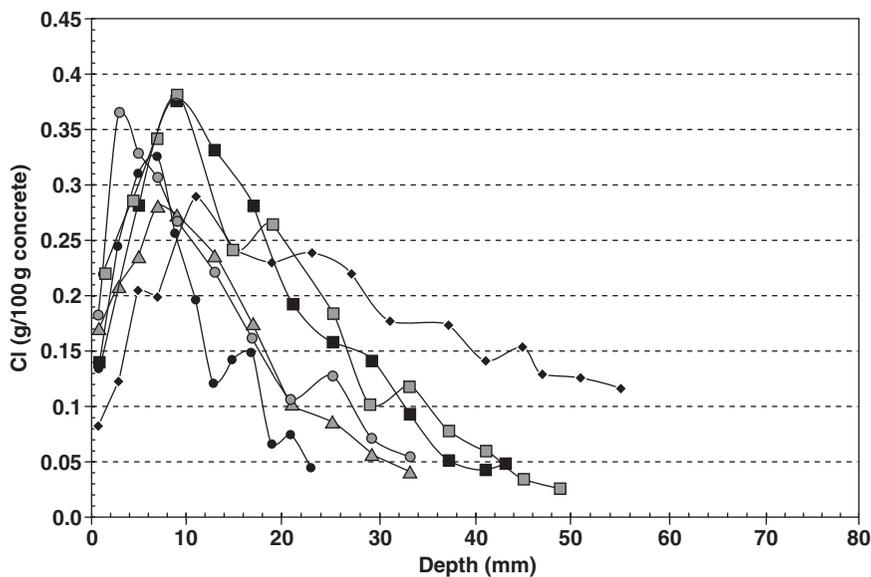
Figure 2.60 The Brent C Platform (1978) with observed chloride penetration below water after 17 years of exposure (source: Gjrv (2002)).

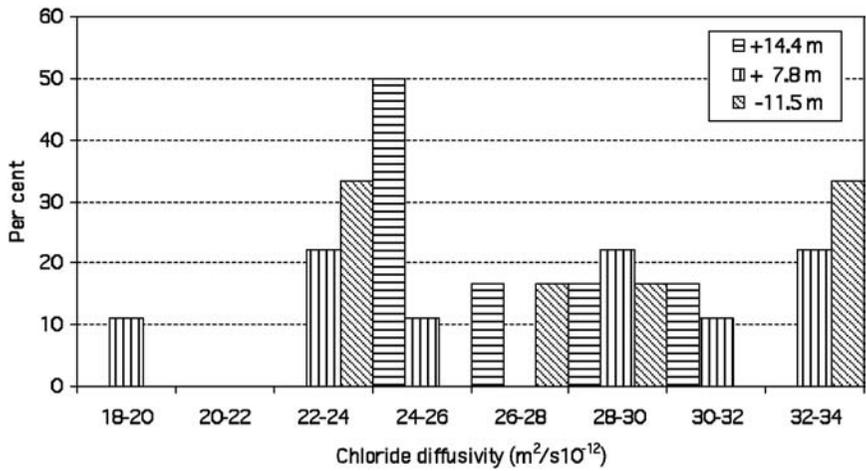
Figure 2.61 Observed chloride diffusivity in the utility shaft of the Brent B Platform (1975) (source: Årskog and Gjørsv (2008)).

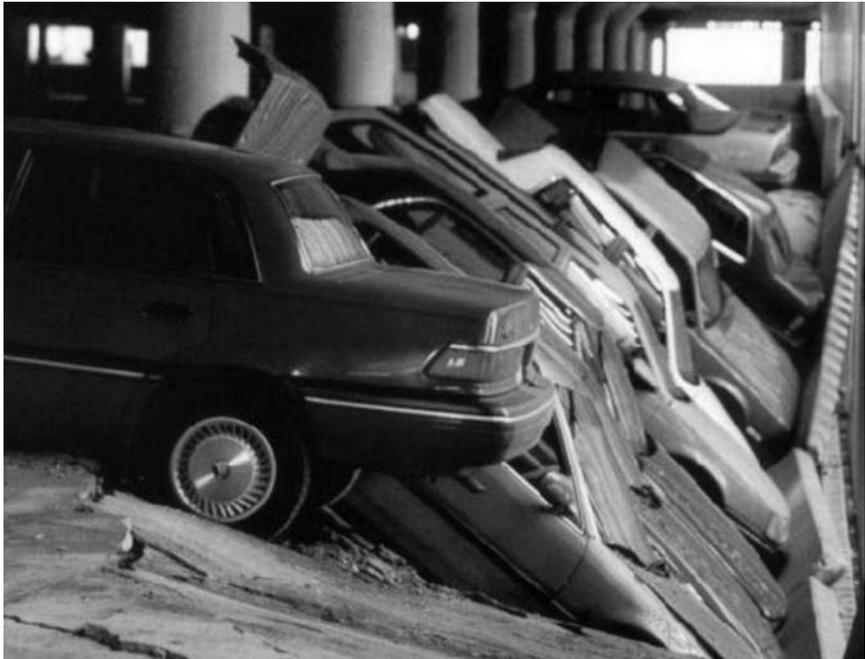
Figure 2.62 The consequences of corrosion in garages exposed to de-icing salt contamination have occasionally been quite severe (source: Courtesy of Sten H. Vælitlalo).

In addition to the field performance of the various types of concrete structures outlined above, there are also a variety of other types of concrete structures which are showing problems due to an uncontrolled durability. In the marine environments, there are a number of buildings and other facilities which are also suffering from chloride-induced corrosion. In addition to all the highway bridges, there are a large number of garages which are suffering from severe corrosion problems due to de-icing salt, the consequences of which have occasionally been quite severe (Figure 2.62).

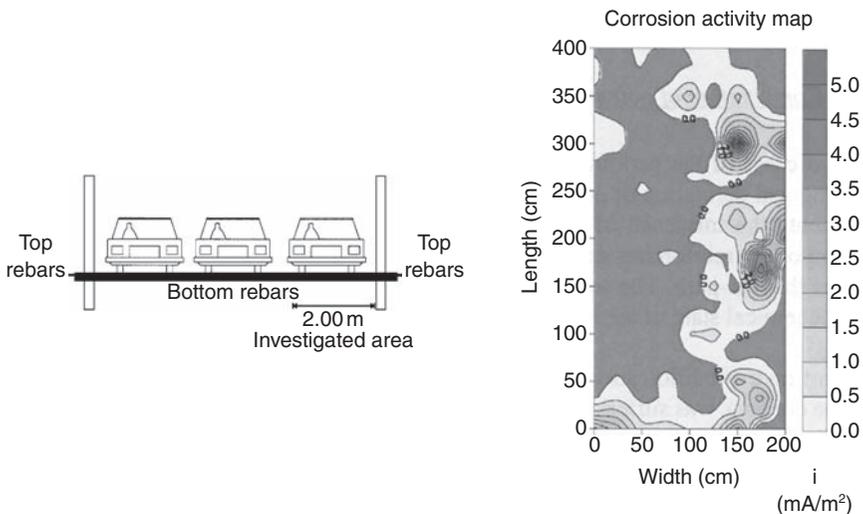
Figure 2.63 Typical pattern of corrosion activities in the parking bays of a garage (source: Pruckner (2002)).

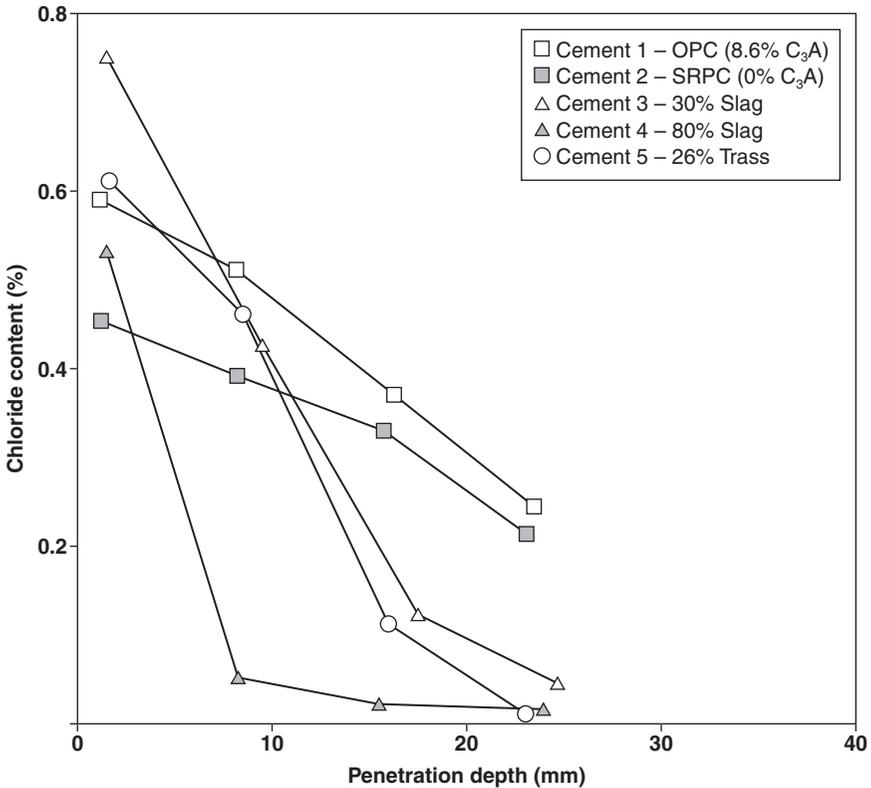
Figure 3.6 Effect of cement type on chloride penetration (by weight of cement) after six months of exposure to seawater (source: Gjørnv and Vennesland (1979)).

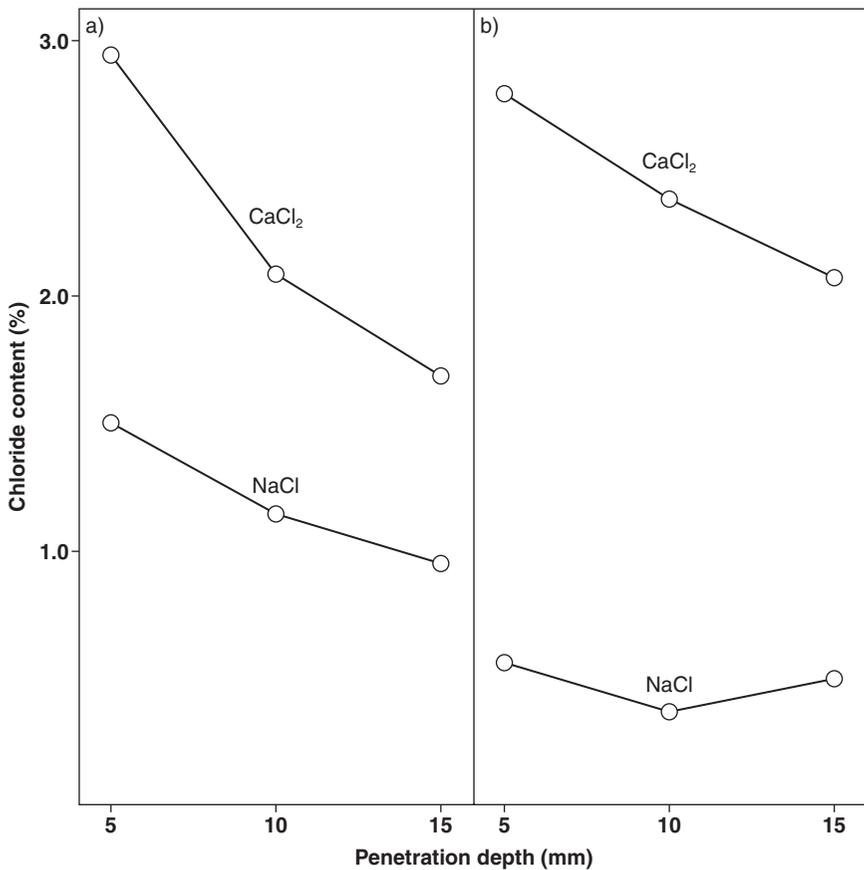
Figure 3.11 Chloride penetration (by weight of cement) into cement paste from two different types of salt solution of the same chloride concentration: (a) after two days of hydration, and (b) after 40 days of hydration before exposure (source: Trættemberg (1977) in Gjorv and Vennesland (1987)).

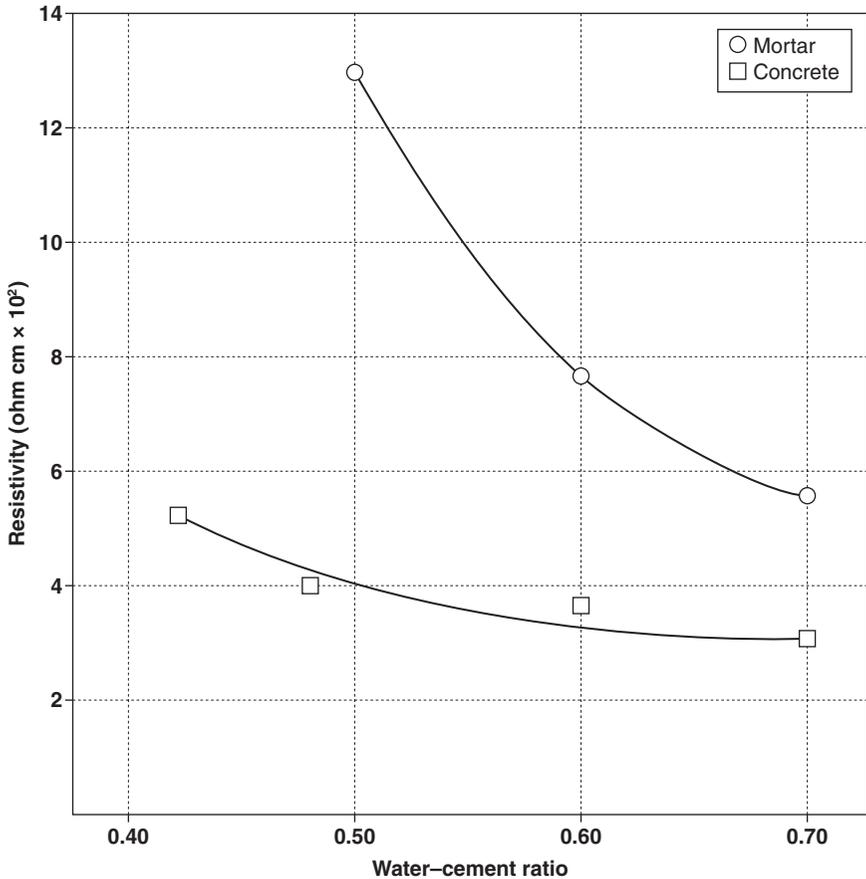
Figure 3.13 Effect of water/cement ratio on the electrical resistivity of concrete (source: Gjrv *et al.* (1977a)).

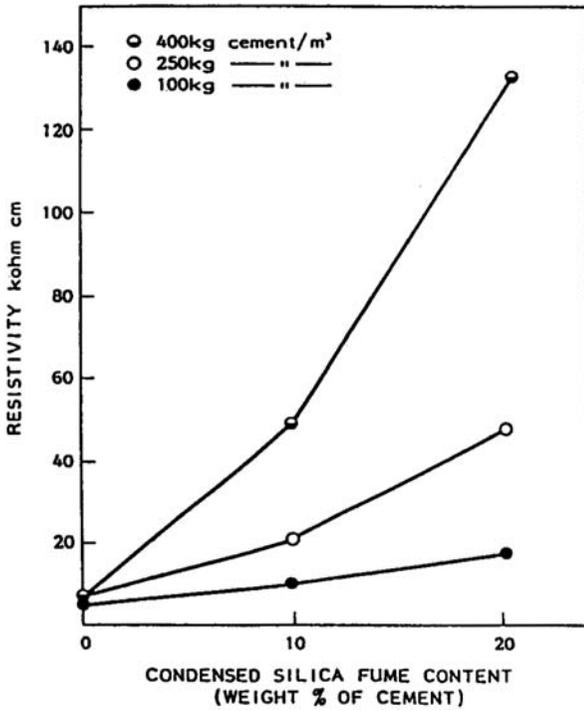
Figure 3.15 Effect of increased additions of silica fume on the electrical resistivity of concrete (source: Vennesland and Gjrv (1983)).

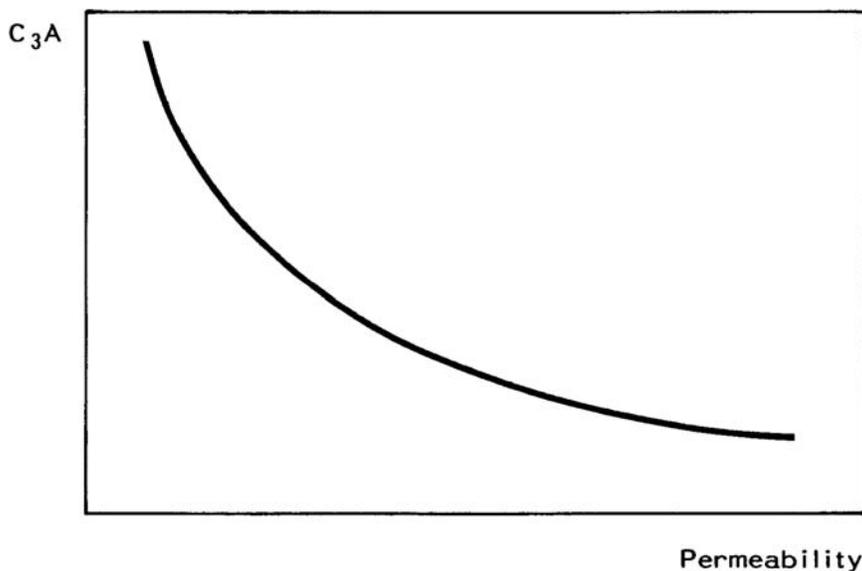
Figure 4.1 Combinations of  $C_3A$  content and permeability for obtaining the same sulphate resistance of concrete based on pure portland cements (source: GjØrv (1983)).

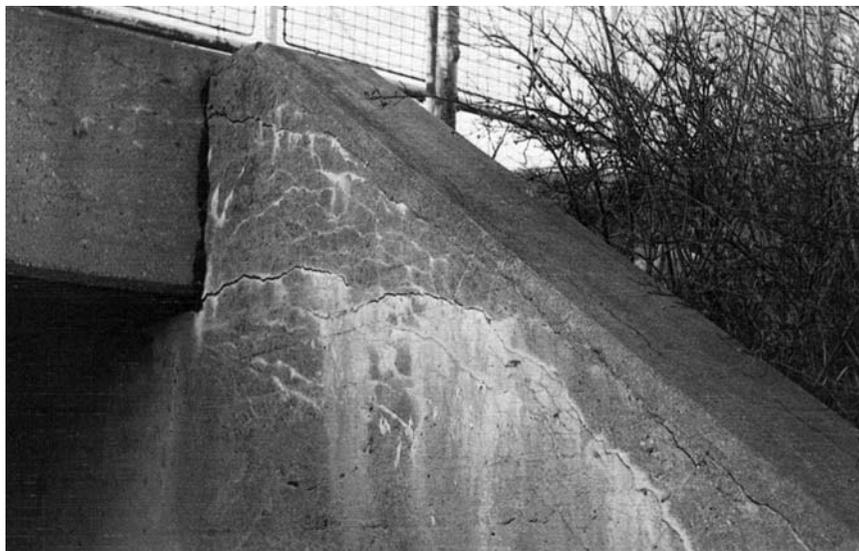
*Figure 4.2* Typical damage due to alkali-aggregate reaction in a retaining concrete wall of a bridge.

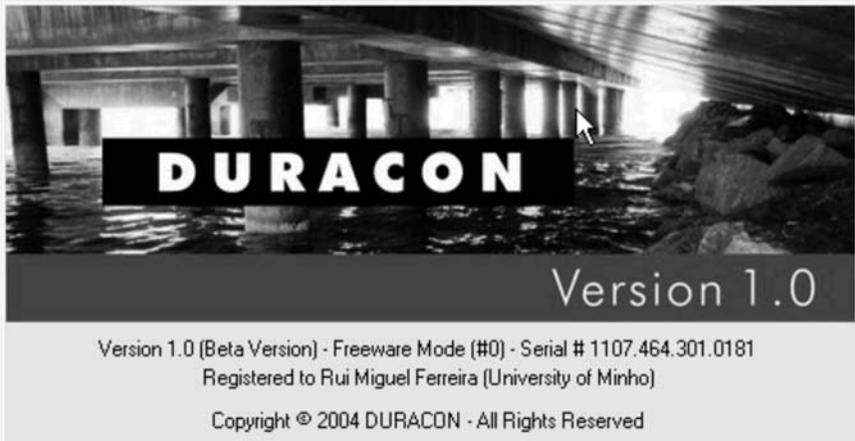
Figure 6.3 Opening window for the software DURACON (2004).

In principle, the calculation of corrosion probability may be carried out by the use of any of the above mathematical methods in combination with the appropriate software. Based on current experience with durability design of concrete structures in chloride-containing environments, however, calculation of chloride penetration by use of equation 6.1 in combination with a Monte Carlo Simulation has proved to give a very simple and appropriate basis for calculating the probability of corrosion (Gjørsv, 2004). Although such a combined calculation may also be carried out in different ways, a special software DURACON (Figure 6.3) for this calculation has been developed (Ferreira *et al.*, 2004a).

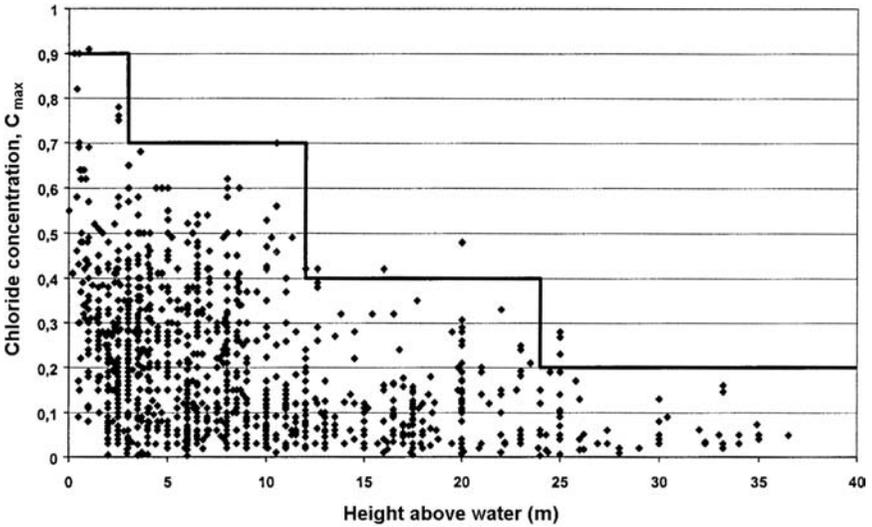
Figure 6.6 Observed maximum surface chloride concentrations by weight of concrete ( $C_{max}$ ) on Norwegian concrete coastal bridges (source: Fluge (2001)).

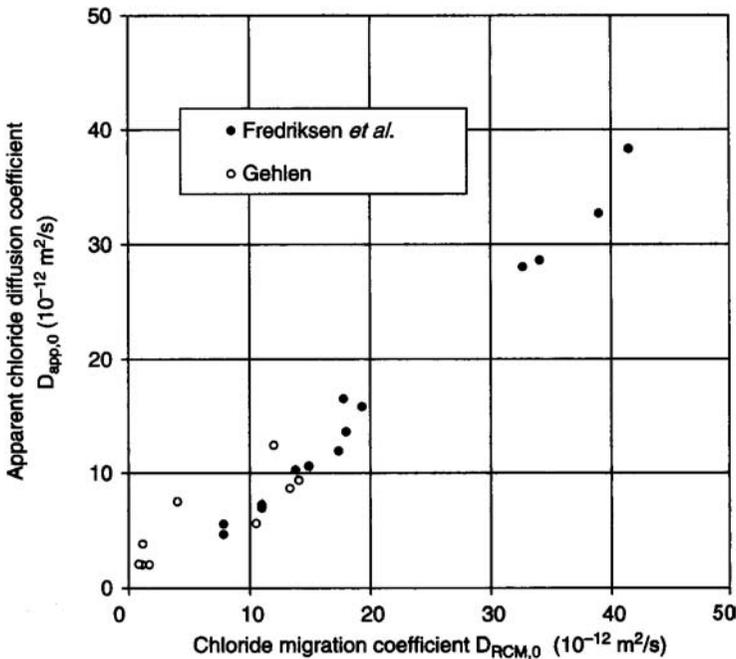
Figure 6.8 Correlation of the effective diffusion coefficients obtained by immersion tests and the RCM method according to Gehlen (2000) and Fredriksen *et al.* (1996) (source: Schiessl and Lay (2005)).

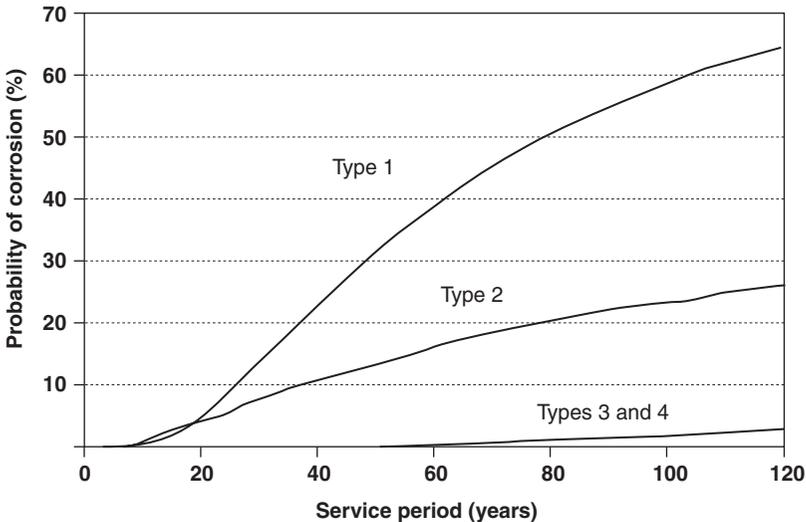
Figure 6.11 Effect of binder system on the probability of corrosion in a relatively dense concrete.

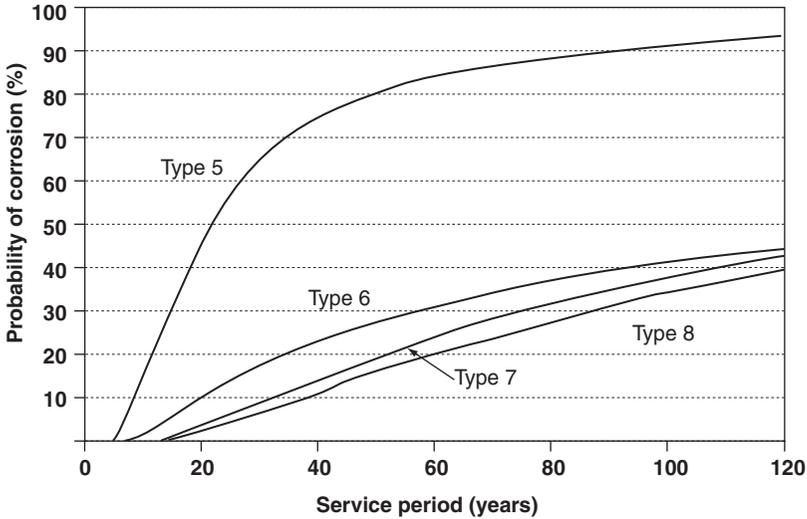
Figure 6.12 Effect of binder system on the probability of corrosion in a relatively porous concrete.

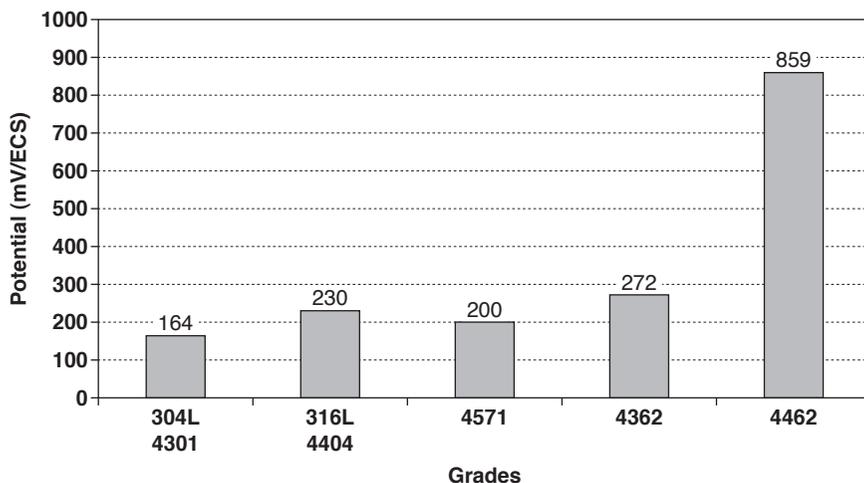
Figure 7.1 Pitting potential (mV/ECS) for various grades of stainless steel in a synthetic medium with pH of 8 and a chloride content of 21 g/l (source: Chauveau and Demelin (2007)).

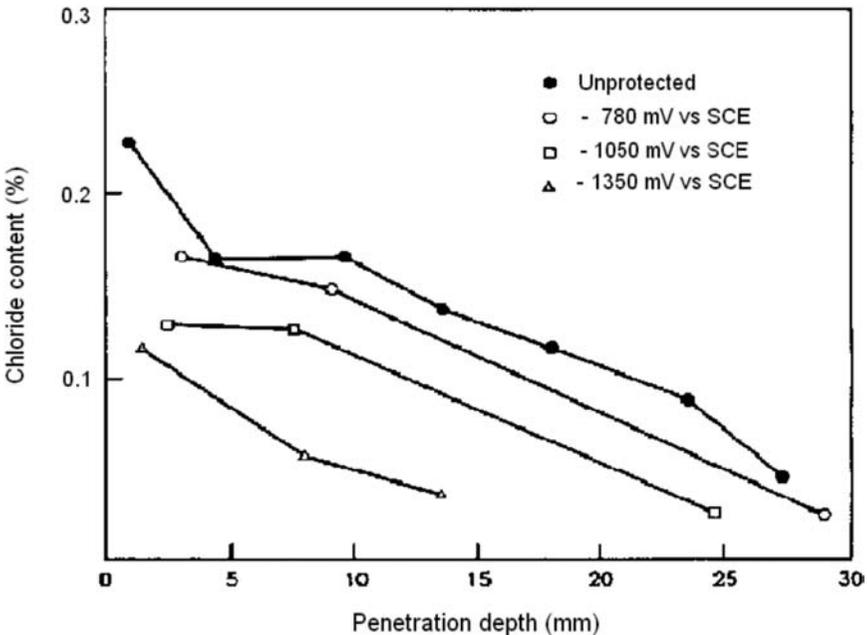
Figure 7.2 Effect of protection potential on chloride penetration into submerged concrete structures (source: Gjørøv and Vennesland (1987)).

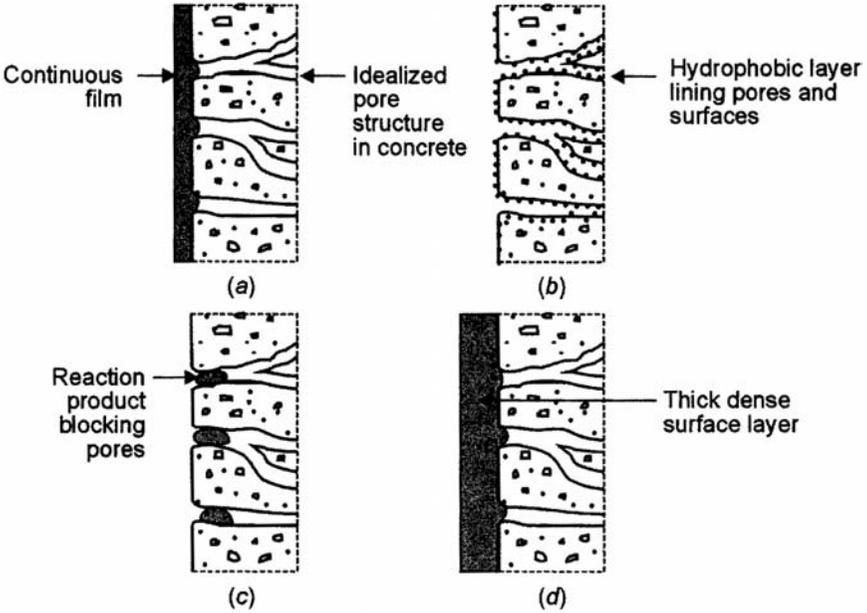
Figure 7.3 Schematic representation of different types of concrete surface protection: (a) organic coating, (b) pore-lining treatments, (c) pore-blocking treatments, (d) thick cementitious coating, shotcrete or rendering (source: Bijen (1989)).

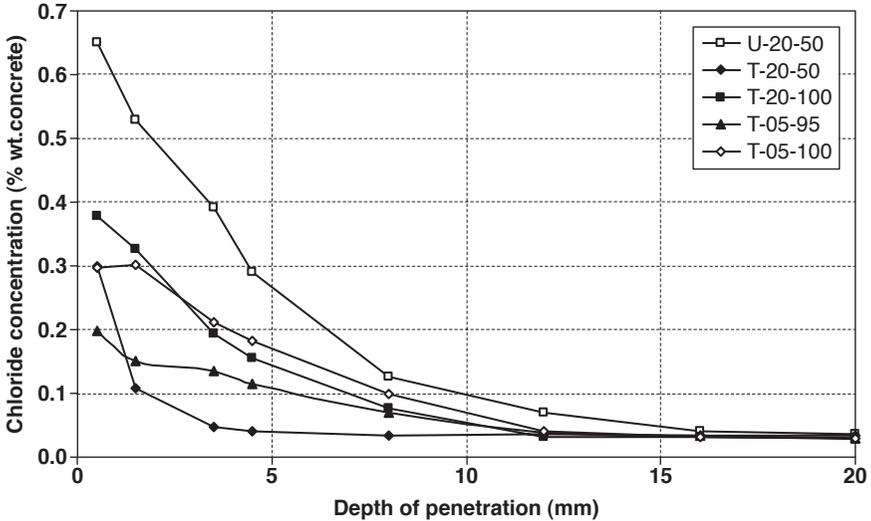
Figure 7.4 Protective effect of a surface hydrophobation against early age chloride exposure (source: Liu *et al.* (2005)).

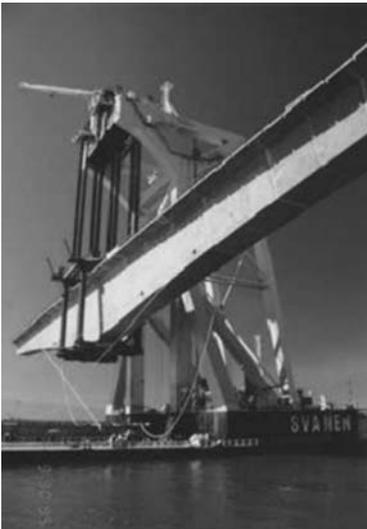
Figure 7.7 Precast cantilever girder for the Northumberland Strait Bridge.

For many concrete harbour structures, prefabricated concrete elements are often applied both for formwork and deck slabs. For many concrete bridges, prefabricated deck beams and girders as well as large structural elements are also often used. For some bridges, the prefabricated structural elements may be very large. Thus, for the Northumberland Strait Bridge Project on the east coast of Canada (Tromposch *et al.*, 1998), both the pier shafts and the cantilever girders of up to 190m length were prefabricated on shore before they were installed by use of a heavy floating crane (Figures 7.6–7.9).

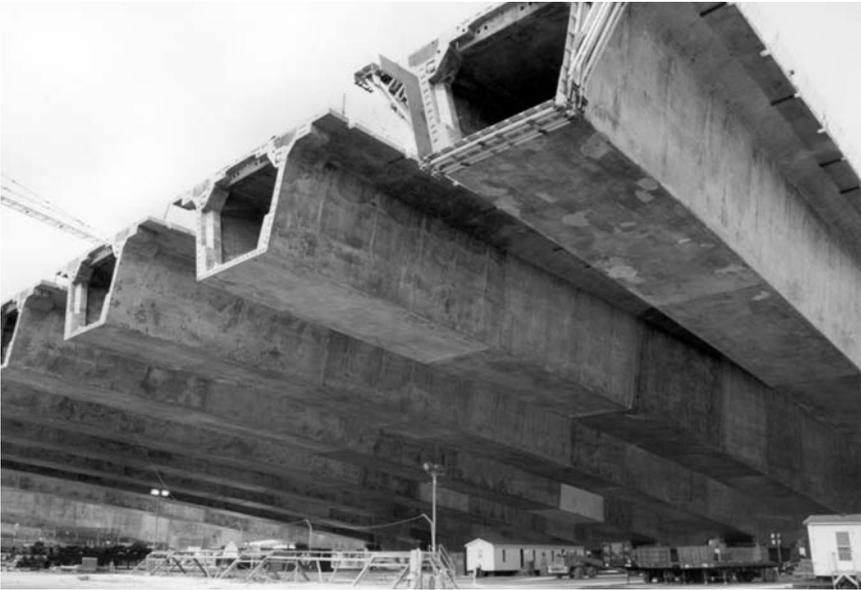
*Figure 7.8* Precast cantilever girders for the Northumberland Strait Bridge.

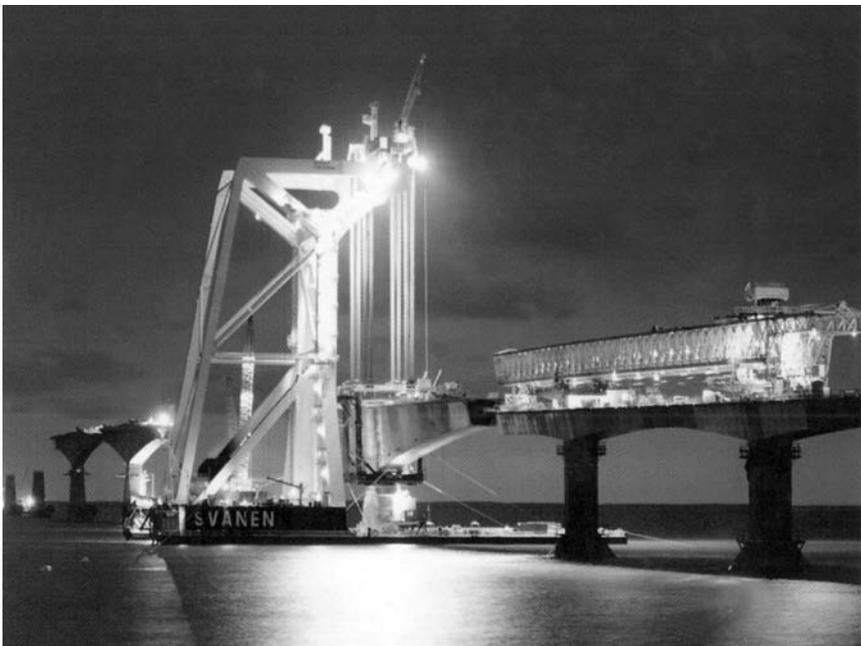
*Figure 7.9* Installation of cantilever girders for the Northumberland Strait Bridge (source: Malhotra (1996)).

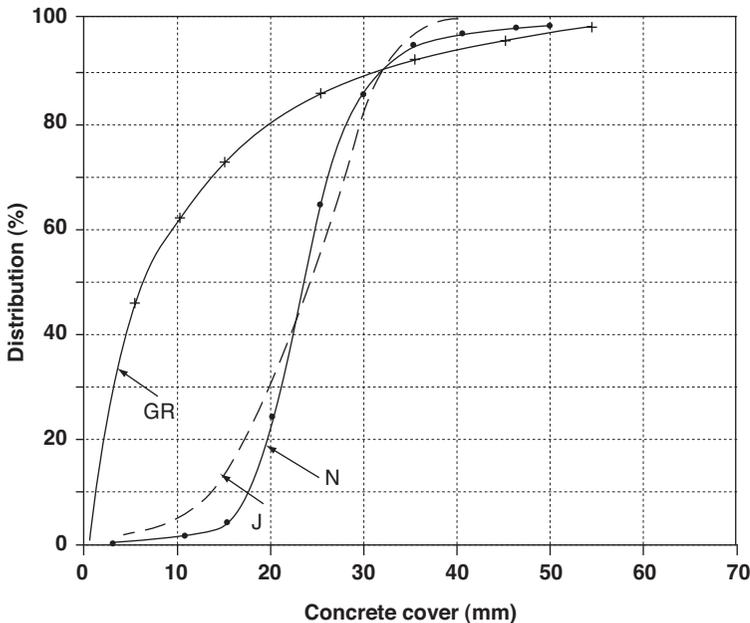
Figure 8.1 Variation in achieved concrete cover (mm) in the Gimsøystraumen Bridge (N) previously shown in Figure 2.40 compared to that of a Japanese bridge (J) and more than 100 concrete structures in the Gulf Region (GR) (source: Kompen (1998)).

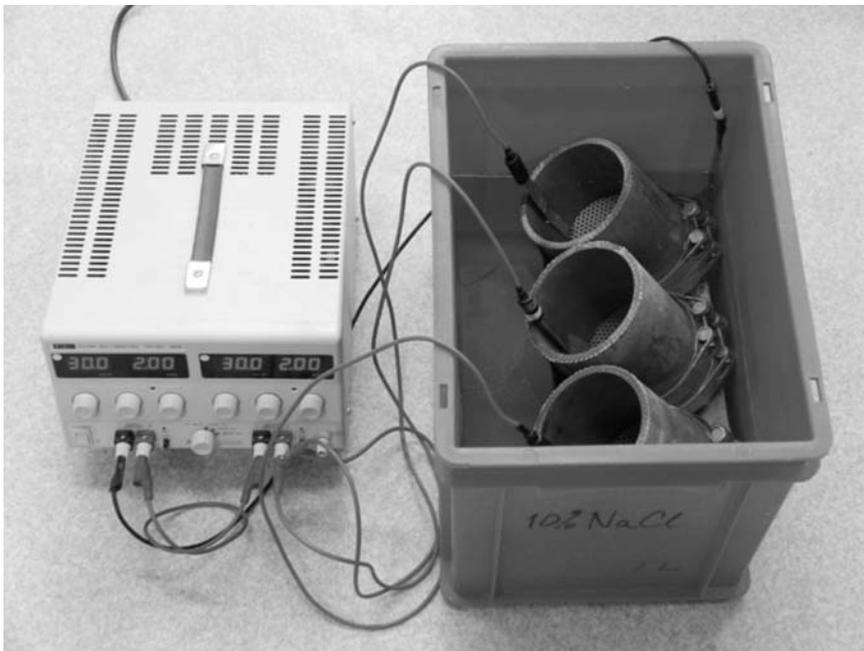
Figure 8.4 Concrete specimens under testing with the RCM method (source: Tang (2008)).

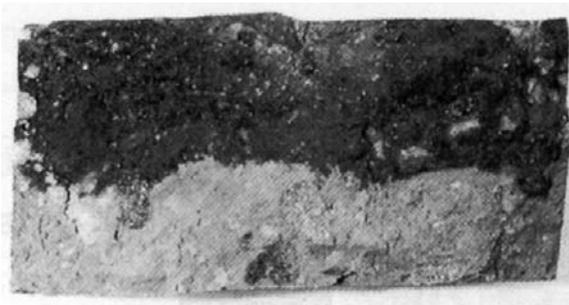
*Figure 8.5* Observed depth of chloride penetration on the split concrete surface after a spraying of the surface with a standard  $\text{AgNO}_3$  solution.

When the resistance of the concrete to chloride penetration is characterized by the RCM method as described above, it should be very clear that the results obtained on the basis of such an accelerated chloride penetration are very different from what is taking place under more realistic and normal conditions in the field. Therefore, this type of testing primarily distinguishes the difference in chloride mobility in the concrete from one type of concrete to another, and does not properly reflect the difference in the ability of the various types of binder system to bind the penetrating chlorides. Hence, all results obtained by the above accelerated test method should only be considered as a simplified way of comparing the resistance to chloride penetration of various types of concrete. For equal concrete

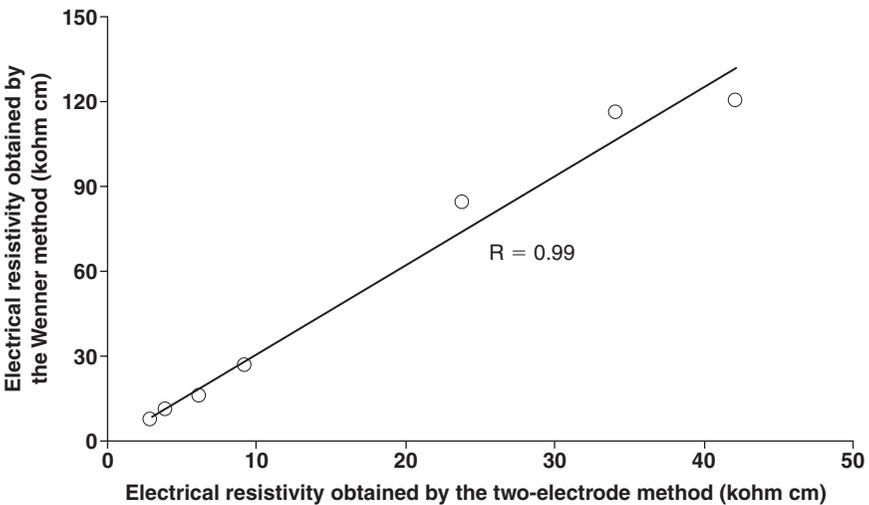
Figure 8.9 Relationship between the resistivities obtained by the Wenner method and the two-electrode method (source: Sengul and Gjørsv (2008)).

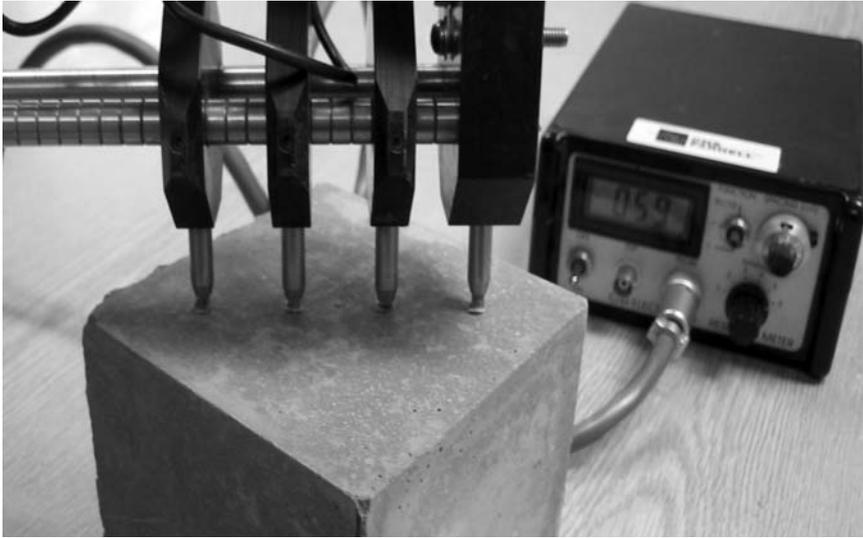
Figure 8.10 Measurement of electrical resistivity on 100mm concrete cubes (all measures in mm).

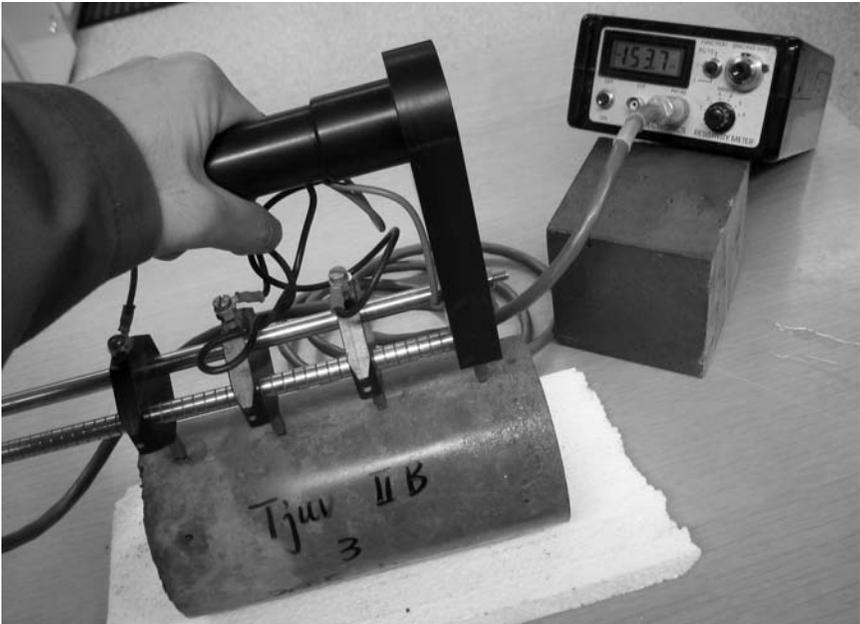
Figure 8.11 Measurement of electrical resistivity on  $\text{Ø } 100 \times 200$  mm concrete cylinders (all measures in mm).

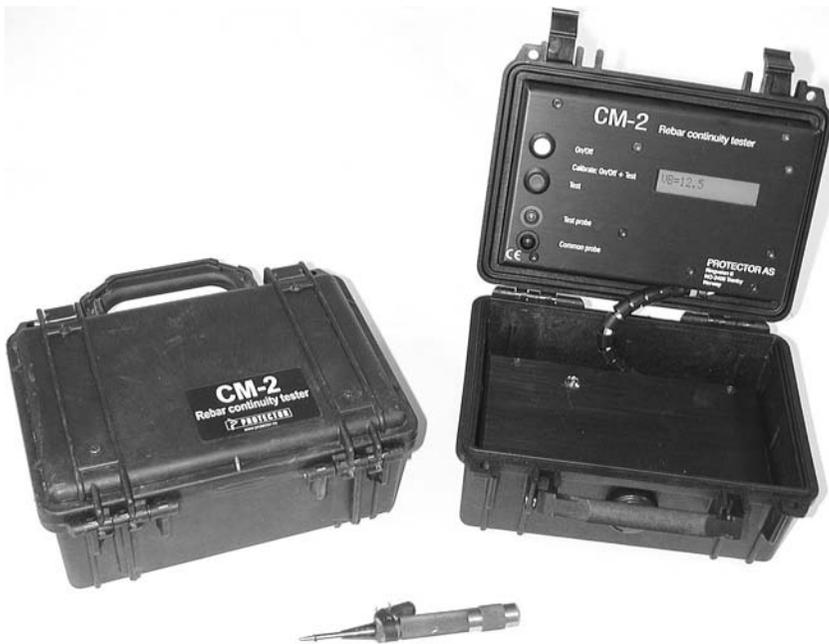
*Figure 8.13* Equipment for control of electrical continuity within the reinforcement system (source: Protector (2008)).

In principle, electrical continuity is controlled by measurements of the ohmic resistance between various parts of the reinforcement system. In order to avoid the uncertainty of measurements when a traditional multimeter is applied, the measurements should preferably be carried out by the use of a relatively high current (1 A) between the various parts of the reinforcement. Commercial equipment for such measurements is available, where both the ohmic resistance and the rest voltage between the measuring parts 0.1 seconds after interruption of current are observed (Figure 8.13).

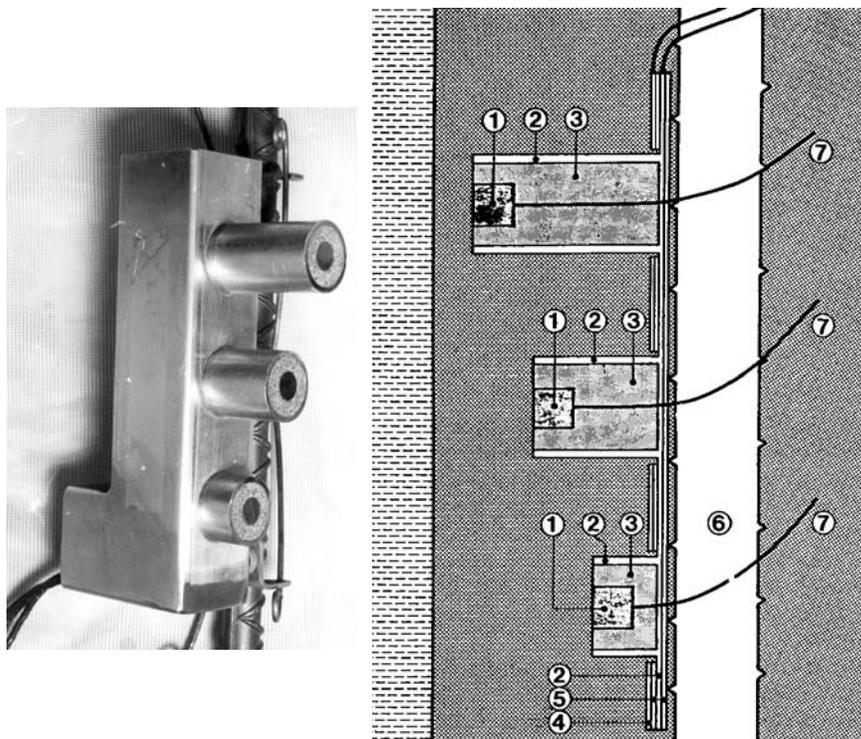
Figure 10.1 Probe for automatic monitoring of chloride penetration into concrete structures: (1) electrode, (2) casing of stainless steel, (3) insulation, (4) reference electrode, (5) insulation, (6) rebar system, (7) shielded leads (source: Gjrv and Vennesland (1982)).
