# DURABILITY DESIGN OF CONCRETE STRUCTURES IN SEVERE ENVIRONMENTS

**ODD E. GJØRV**

Taylor & Francis

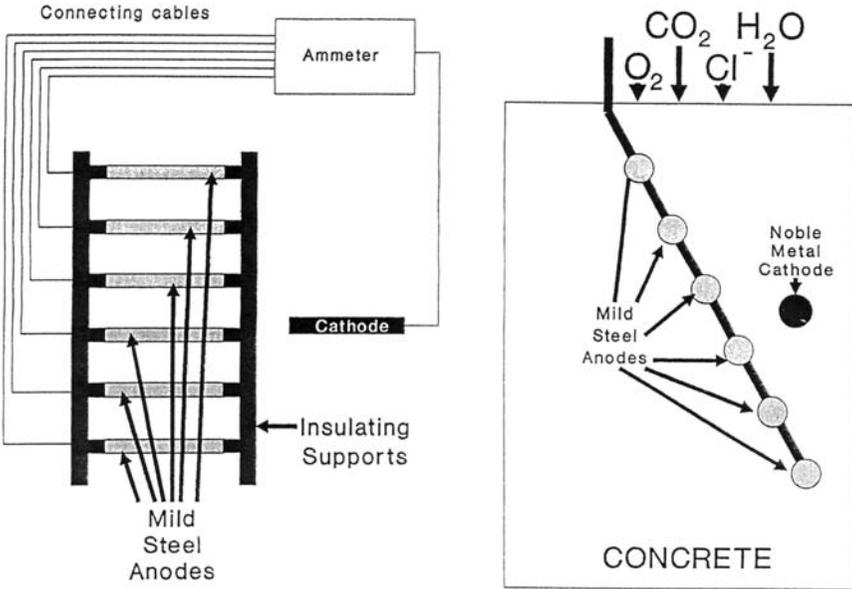
Figure 10.2 Probe for automatic monitoring of chloride penetration into concrete structures: Anode ladder (source: Raupach and Schiessl (1997)).

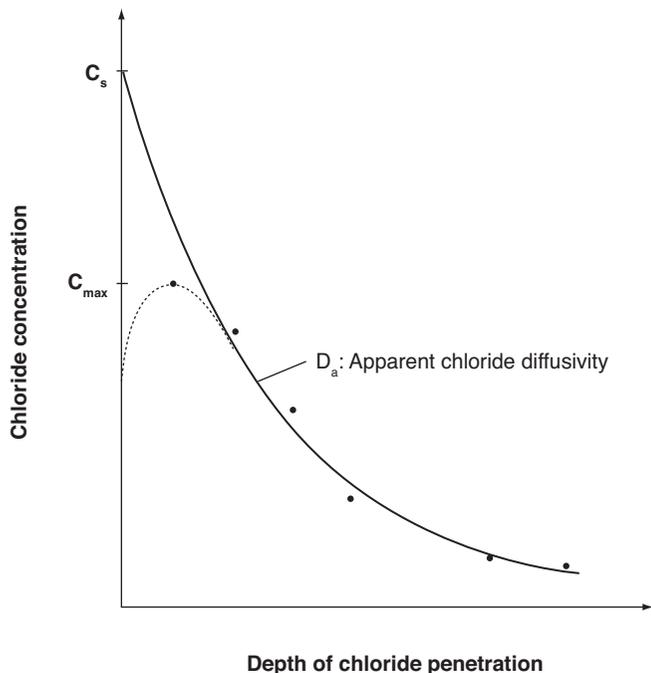
Figure 10.4 The apparent chloride diffusivity ( $D_a$ ) is the result of a regression analysis of all observed data on chloride penetration at the given time of observation.

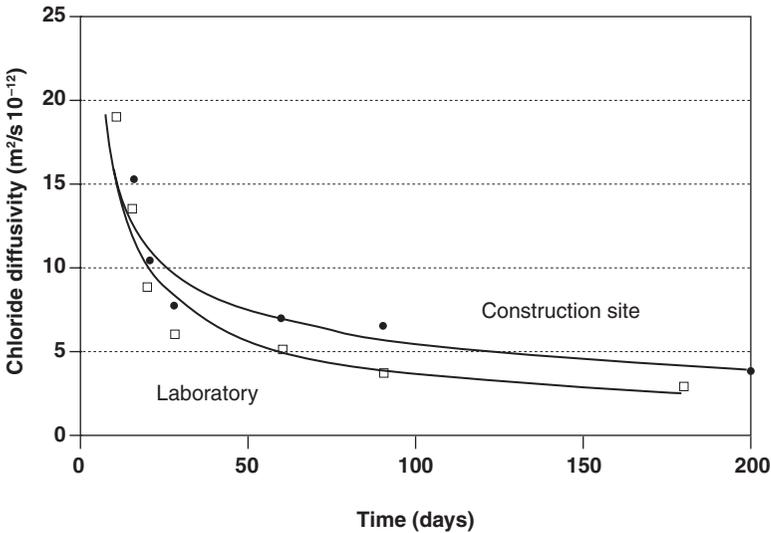
*Figure 11.1* Development of chloride diffusivity on the construction site and in the laboratory.

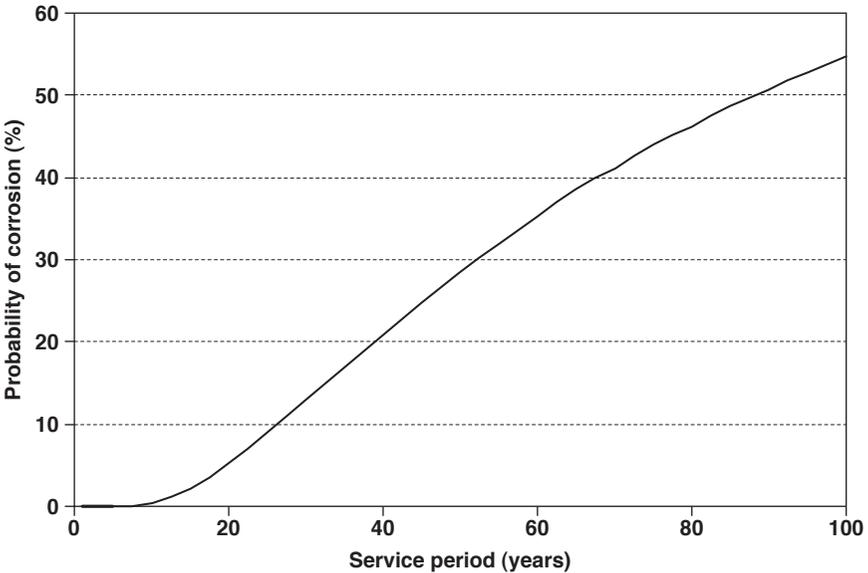
Figure 11.2 Probability of corrosion versus time for 'Nye Filipstadkaia' (2002) in Oslo Harbour.

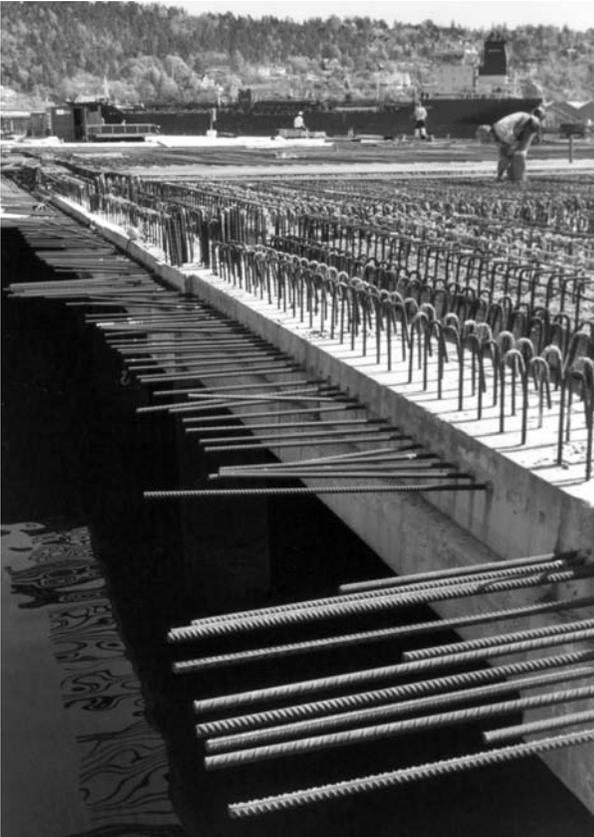
Figure 11.4 Protruding bars in the joints of the concrete deck.

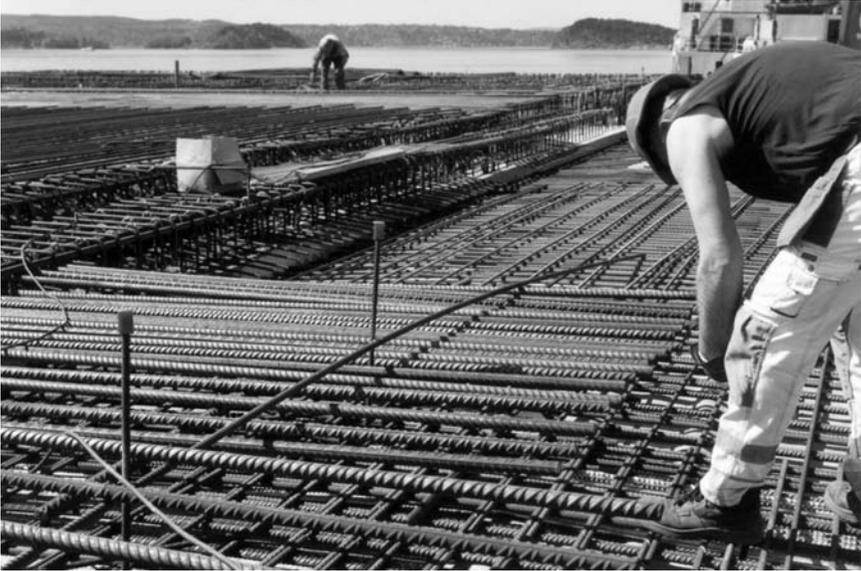
Figure 11.5 The concrete deck had very congested reinforcement.

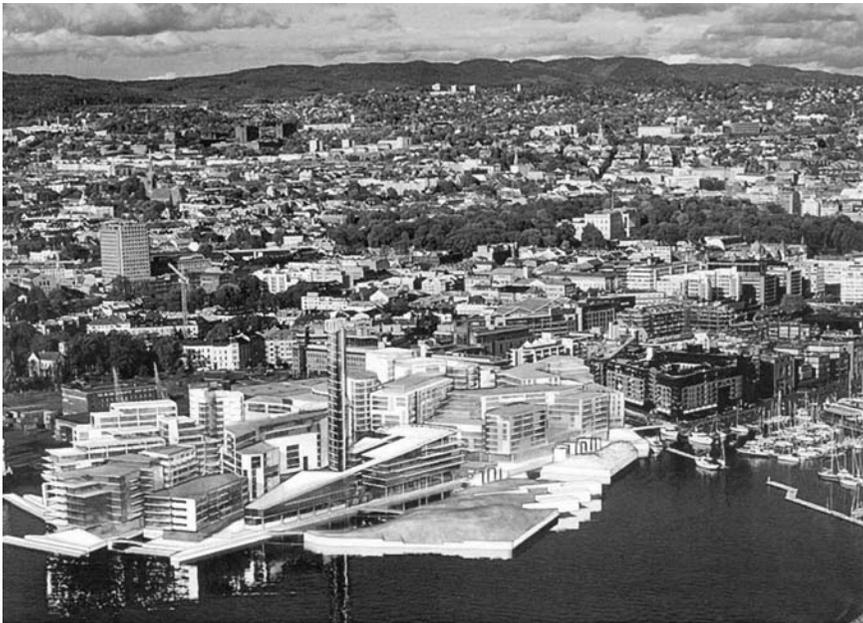
Figure 11.7 A new city development currently under construction on Tjuvholmen in the harbour region of Oslo City (source: Courtesy of Tjuvholmen KS).

In 2005, a new city development project ('Nye Tjuvholmen') was started in the Oslo harbour region. This project includes a number of concrete substructures located in various water depths of up to 20m, on top of which a number of business and apartment buildings are being constructed, as is shown in Figure 11.7. Most of the concrete substructures which are still under construction include large submerged parking areas. Most of the substructures in the more shallow water include a solid concrete bottom slab on the sea bed surrounded by concrete walls partly protected by stone fillings and partly freely exposed to the tidal zone. In the deeper water, some of the structures include an open concrete deck on top of solid columns consisting of driven steel pipes filled with concrete. For the deepest water, three large concrete caissons are currently under construction in a dry dock of a shipyard nearby and will upon completion be moved into position and submerged in water depths of up to 20m. These prefabricated concrete units will provide large submerged parking areas in four levels (Figure 11.8).

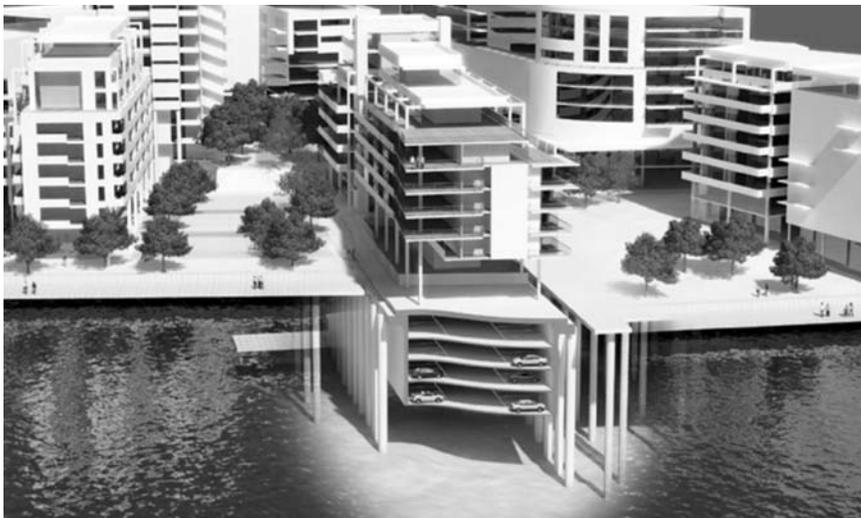
*Figure 11.8* A model section showing how the prefabricated concrete caissons after installation will provide large submerged parking areas in four levels (source: Courtesy of Skanska).

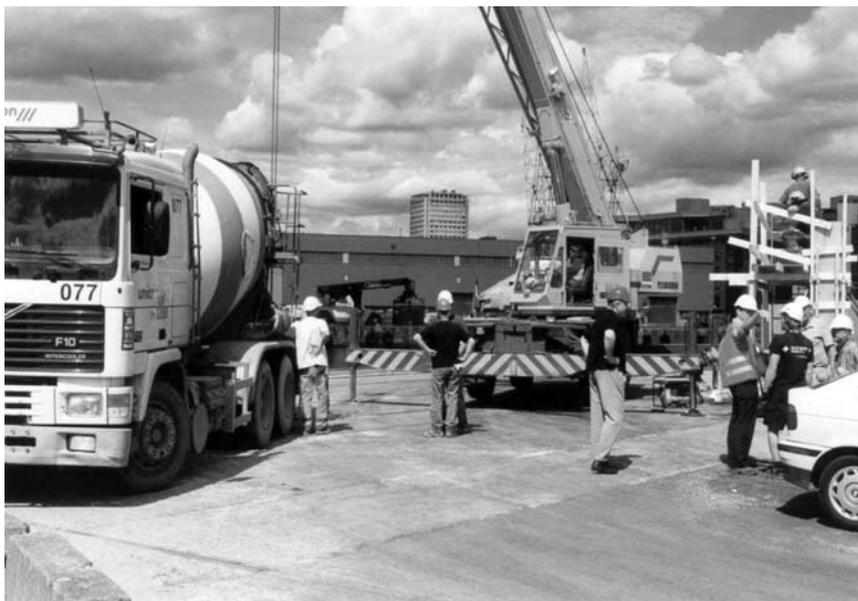
Figure 11.9 Production of a test wall element on the construction site.

For each new concrete structure, two new test elements were produced on the construction site at an early stage of concrete construction. These elements included both a wall element and a slab element produced and cured as representative as possible for the real concrete structure (Figures 11.9, 11.10(a) and 11.10(b)). From these elements, a number of  $\varnothing 100$  mm

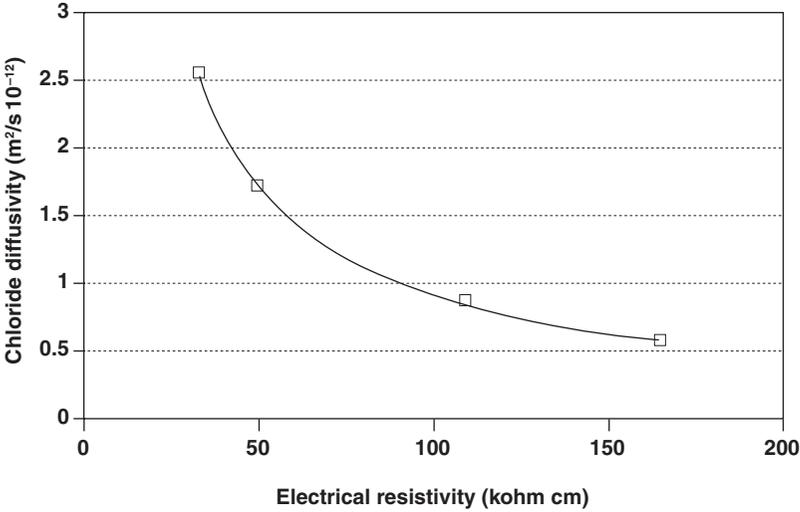
Figure 11.11 Calibration curve for control of chloride diffusivity based on electrical resistivity measurements.

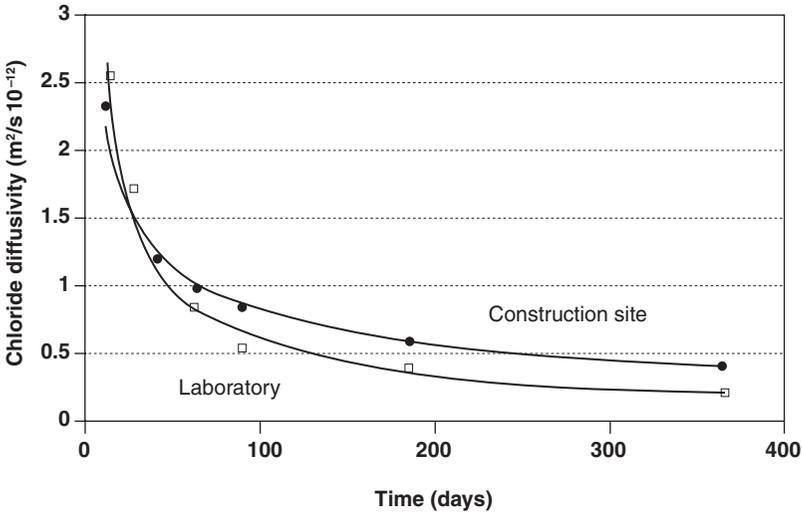
Figure 11.12 Development of chloride diffusivity on the construction site and in the laboratory.

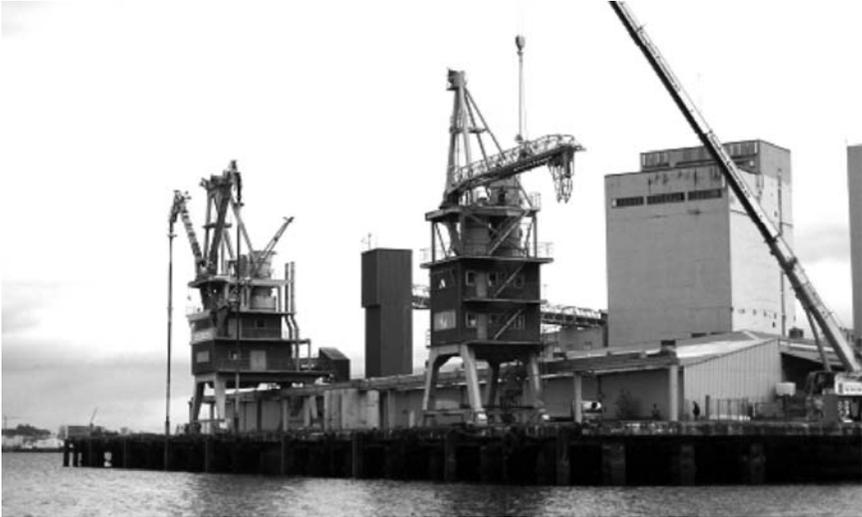
*Figure 12.1* A heavily corroding concrete harbour structure from 1964 in Trondheim (source: Courtesy of Trondheim Harbour KS).
